PIOTR J. PODHORECKI, Ph.D, peter_podhorecki@urscorp.com, podhorec@gmail.com
MARK GUZDA, M.Sc., mark_guzda@urscorp.com
ED ZHOU, Ph.D., ed_zhou@urscorp.com
URS Corporation, Hunt Valley, MD, USA
Prof. dr hab. inż. ADAM PODHORECKI, podhorec@utp.edu.pl
University of Technology and Agriculture in Bydgoszcz

DAMAGE INVESTIGATION USING LONG-TERM MONITORING AND RETROFIT CONCEPT DEVELOPMENT FOR A HIGHWAY TRUSS BRIDGE STRUCTURE IN THE USA

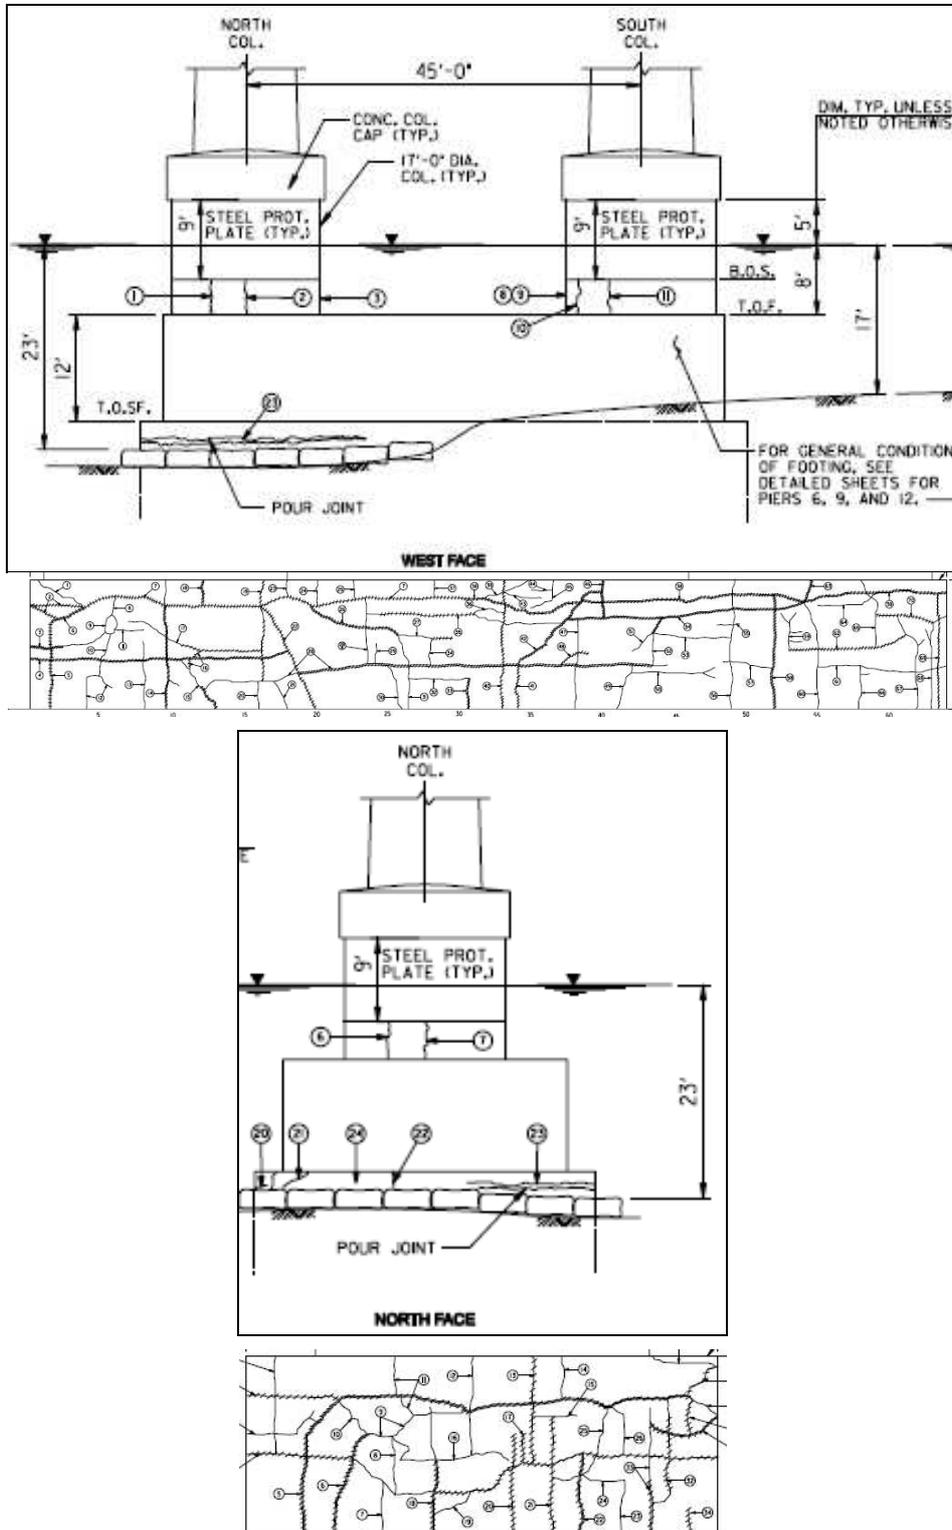
The spread footing at pier 3 is not visible due to high mudline at this location. The spread footings at Piers 4 and 5 are partially exposed and are in fair condition. Spread footings at Piers 6 through 12 are in poor to serious condition due to extensive horizontal and vertical cracking. Overall, less than 50% of the observed cracks have undergone repair and a majority of the repaired locations are experiencing further cracking due to failed or failing repairs. In particular, the most concerning cracks observed were previously repaired horizontal cracks that were epoxy injected in the nineties of the 20th century and have since reopened significantly. In pier 6 for example, an epoxy injection repair was done for a 13 mm wide horizontal crack in the nineties and the most recent inspection found the epoxy material in-tact, but now the horizontal crack opened an additional 6 mm. The total crack opening is thus around 20 mm. Similar conditions occurred in numerous locations, with horizontal shift of concrete below the crack in reference to concrete above.

The original tremie concrete subfootings are only exposed at piers 6 and 7 and the encased tremie concrete subfootings are partially exposed at piers 8 thru 12. Pier 7 is the most exposed subfooting with only 1.0 m of visibility from the top of the subfooting. The subfooting of pier 7 is assumed to be representative for all the piers and is considered to be in poor condition. The concrete is primarily latent and appears to have been dropped in place rather than constructed with actual tremie pours. Intermittent latent pockets are up to 10 cm deep. Only one pour joint is visible and that joint has opened between roughly 13 to 20 mm. Latent concrete is present below the pour joint and honeycombing is present above the pour joint. Additionally, the subfooting section below the pour joint has shifted outward in several

locations. There are several large vertical cracks on one face of subfooting that are opened up to 16 mm wide and continue below the mud line, with evidence of movement and rotation.

Figure 4. North and West faces of pier 7 with details of crack pattern

In comparison to the earlier 2000 underwater inspections, the quantity and size of cracks in the 2006 underwater inspections have increased significantly in all portions of the substructure. The 2006 underwater inspections strongly recommend a thorough engineering analysis of the pier cracking and a long-term retrofit of the substructure for this bridge.

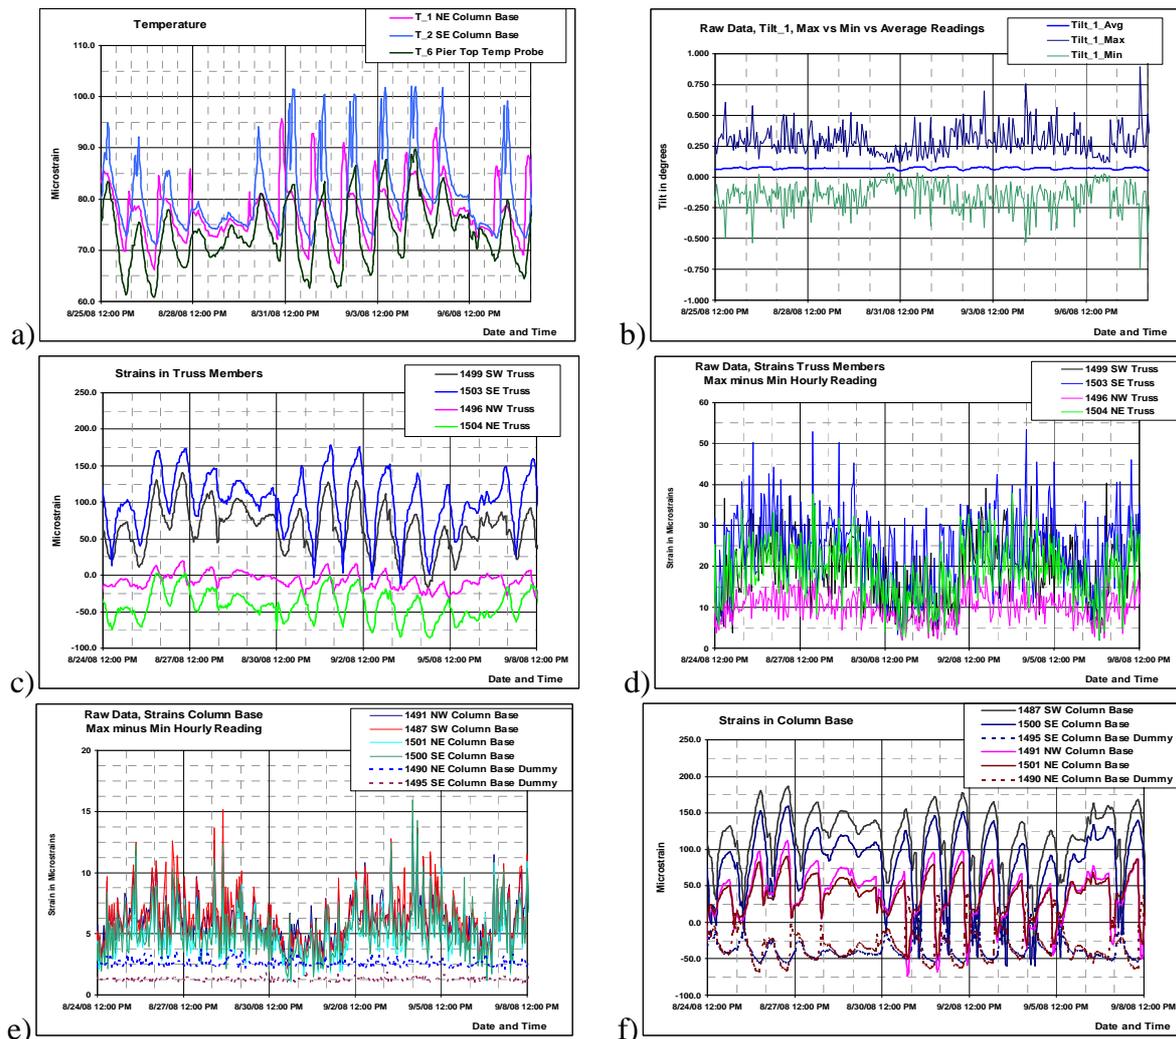
Measurements from a selected tiltmeter are presented in Figure 7b. The selected tiltmeter is located at the top of the pier and measurements are in terms of relative rotation in the longitudinal direction of the bridge. Average rotational gradients were found to be relatively small and when compared to the plots of the temperature gradient, a clear trend exists suggestive that the rotational position of the pier conforms to the effects of superstructure elongation from thermal gradients. The extreme (maximum and minimum) measurements were observed to have greater short term effects on pier rotation than thermal effects. The extreme measurements are believed to have been caused by the short term live load effect. The maximum average rotational gradient (thermal) was observed on day 7 to be around 0.06 degrees, corresponding to 1.2 cm of longitudinal translation at the top of the pier. The maximum extreme gradient (live load) was observed to be around 0.9 degrees, corresponding to 15 cm of longitudinal translation at the top of the pier. The rotational

response of the pier is reasonable. Pier 9 experiences some relatively insignificant bending due to a slow thermal effect.

Figure 7. Readings from thermocouples, tiltmeters and strain gages on truss members and steel columns

The expansion joints and the truss rocker bearings work as designed and allow for nearly free movement. Pier 9 experiences significant bending, most likely due to the frozen response of the rocker bearings, when subjected to high frequency live load changes and dynamic effects. Tiltmeter data for extreme measurements (live load) also illustrated weekly patterns. Larger values of measured rotations were recorded during week days rather than weekends, see days 5–7 and 12–14. This trend is common of truck traffic and serves as good support for crediting extreme measurements to be caused from live load effects.

The trends observed from the tiltmeter response are not confirmed by response of strain gages. The strain gage measurements allow for estimating strains, and based on these stresses and global forces which, in theory, could be related to the measured rotations of pier 9. Figures 7c and 7d illustrate strains in the bottom chord truss members. Figure 7c illustrates average strain readings while Figure 7d illustrates the difference between maximum and minimum readings (the strain gradient from one minutes worth of samples (1200 measurements)). Daily strain gradients from thermal effects (maximum of $180 \mu\epsilon$, corresponding to 53 MPa of normal axial stress) were observed to produce much larger strain gradients than those due to short-term live load (maximum of $54 \mu\epsilon$ corresponding to 15 MPa of normal

axial stress. When comparing measured strain gradients in bottom chord truss members from both each side of the rocker support, it was observed that the maximum difference between daily strain gradient from thermal effects is roughly $100 \mu\epsilon$ (2,9 MPa) and from live load effects is roughly $22 \mu\epsilon$ (0,65 MPa).
