DAISUKE YAMAOKA, *yamaoka_dai_ssd@yahoo.co.jp*

KAZUYA BESSHO, *bessho_ssd@yahoo.co.jp*

FATIGUE TEST OF AN URBAN EXPRESSWAY STEEL GIRDER BRIDGE CONSTRUCTED IN 1964

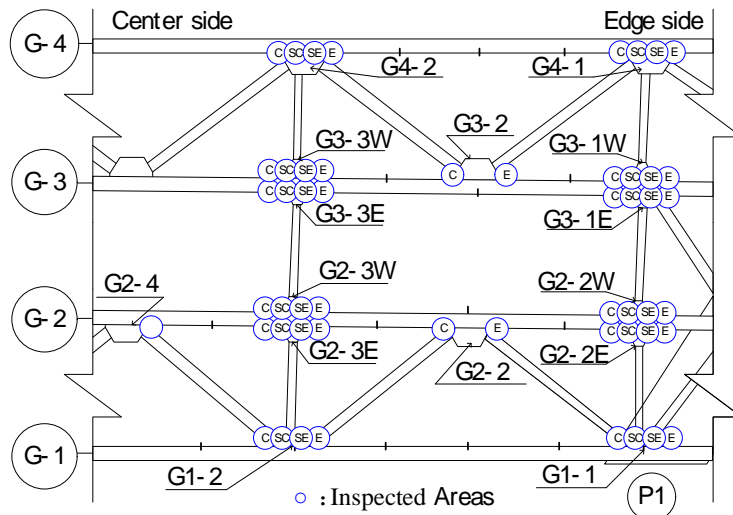
Fig. 4. Locations of gusset plates and inspected areas

Before the fatigue tests, magnetic particle tests are conducted to detect the fatigue cracks which could have occurred under service loading. Toes of turn-round weldment are inspected in the welded joint which connects the gusset plate to the web of the main girder. The total number of inspected toes of turn-round weldment is 53 in 15 gusset plates. Fig.4 shows locations of gusset plates and inspected areas.

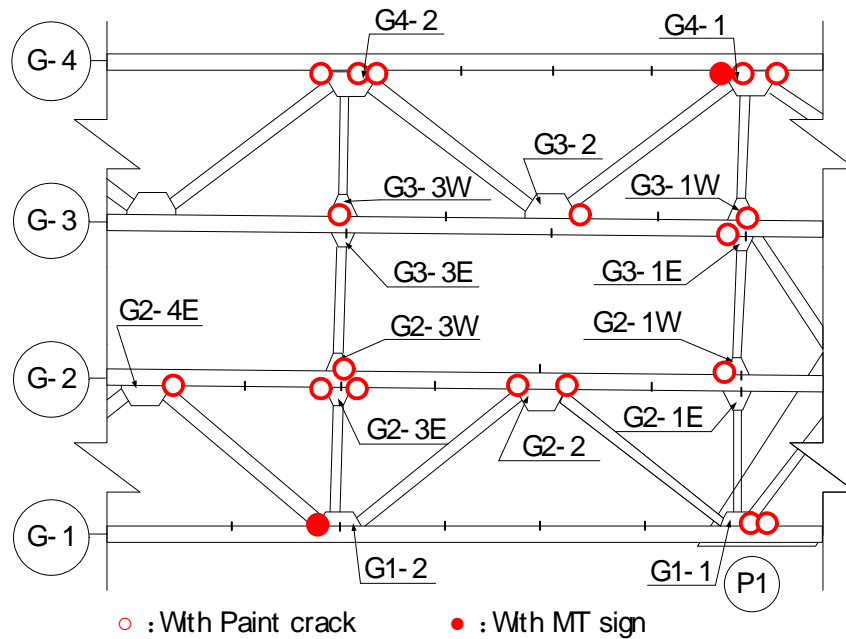
Fig. 5. Results of magnetic particle test

Fig. 5 shows the result of magnetic particle tests. MT signs that may indicate fatigue cracks were observed at 2 weldments among the 18 turn-round weldments with paint cracks. Several paint cracks were observed at the G1-2-C gusset plate.

A MT signs of 8 mm and 1.3 mm length were observed under a 83 mm paint crack at the G1-2-C gusset plate. A MT sign of 4mm length was observed under a 23 mm paint crack at the G4-1-C gusset plate. Photos 1~4 shows paint cracks and MT signs in the G1-2-C and G4-1-C gusset plates.

There are no MT signs in the inspected areas that have no paint cracks, or that have paint cracks in places other than along the toes of turn-round weldment which are fatigue weak points.

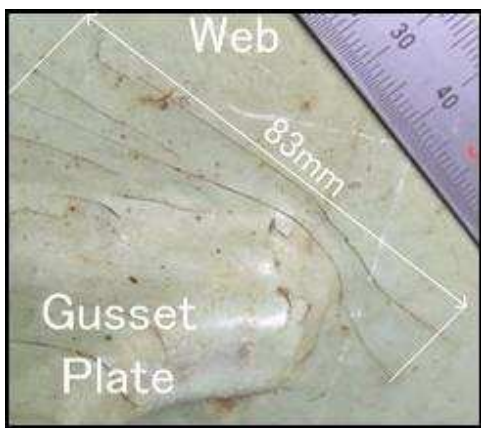
Photo 1. Paint cracks on G1-2-C

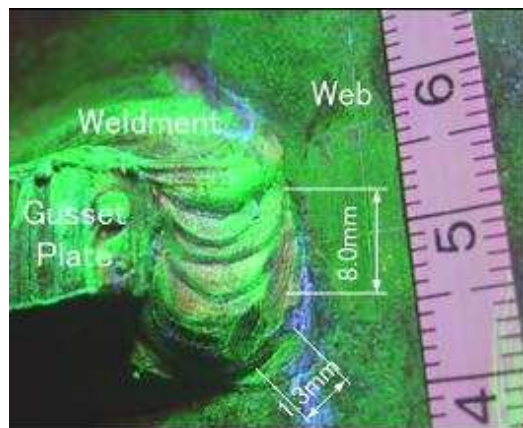
Photo 2. MT sign on G1-2-C (N=0cycle)

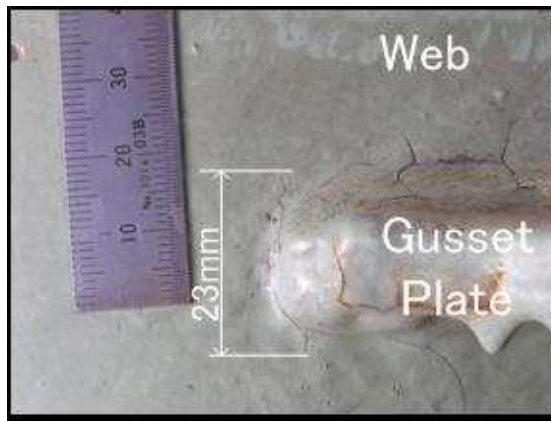
Photo 3. Paint crack on G4-1-C

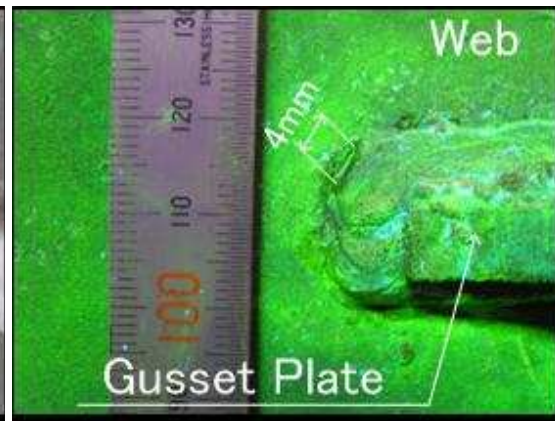
Photo 4. MT sign on G4-1-C

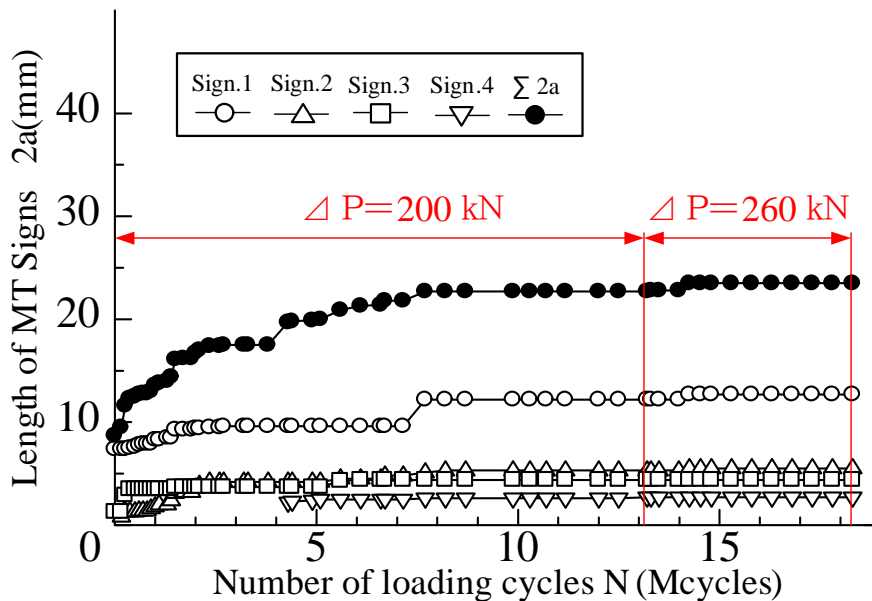
Fig. 8. Relationship between Length of MT Sign and Number of Loading Cycles

Fig. 8 shows the relationship between the length of MT sign and the number of loading cycles. Photo 6, 7 show MT signs at the G1-2-C gusset plate. A MT sign of 0.8 mm length was detected after $\Delta P=200$ kN loading of 0.16 Mcycles at the upper part of G1-2-C weldment. The remarkable propagation of MT signs could not be observed after $\Delta P = 200$ kN loading of 12.5 Mcycles and $\Delta P = 260$ kN loading of 5.1 Mcycles.

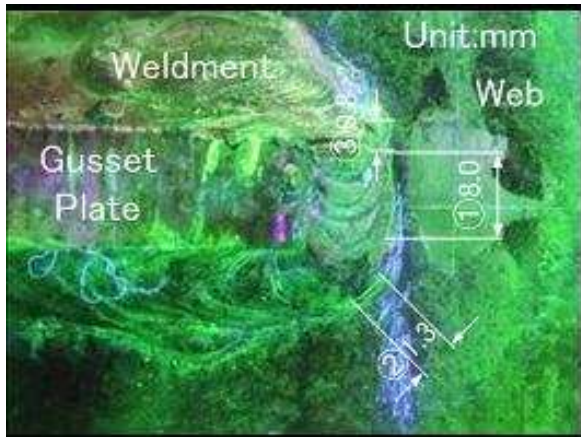
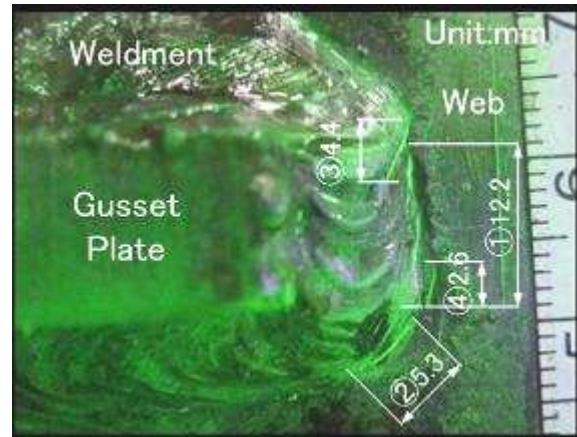
Photo 6 MT sign at G1-2-C (P=200kN, N=0.16Mcycles) Photo 7 MT sign at G1-2-C (P=200kN, N=8.1Mcycles)

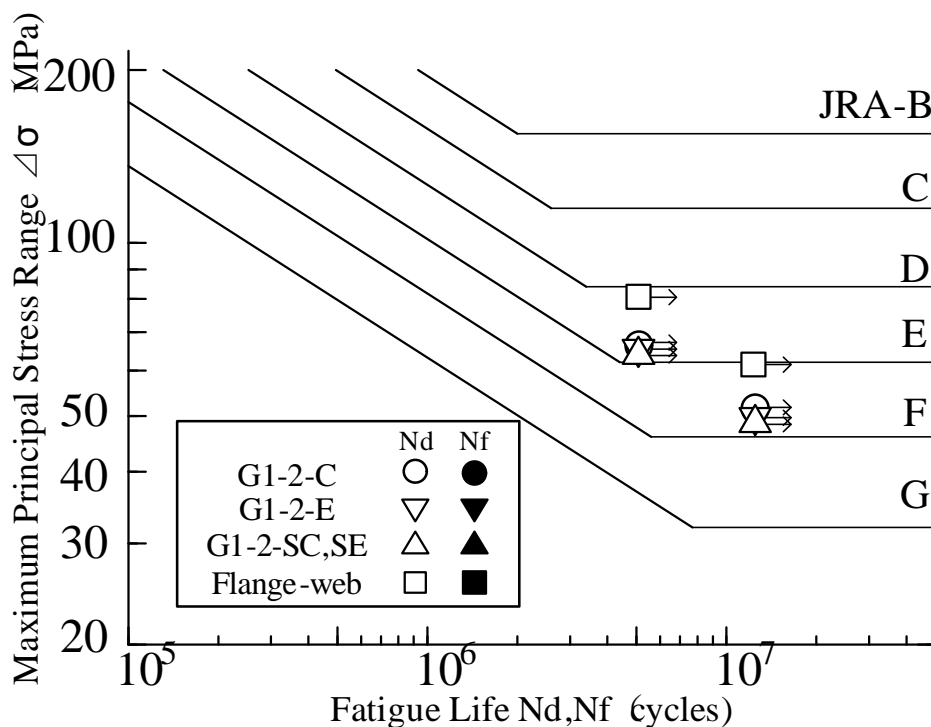
Fig. 9. Fatigue Test Results

Fig. 9 shows fatigue test results and fatigue design curves after JRA (Japan Road Association) Fatigue Design Recommendations for Highway Bridges (2002)^[1]. The vertical axis represents the maximum principal stress range (Δ), while the horizontal axis represents the fatigue life N_d and N_f . N_d is fatigue crack detection life as the number of stress cycles until fatigue cracks are detected. N_f is fatigue life defined as the number of stress cycles until the fatigue crack propagates until the web depth.

No fatigue crack propagation was observed in the gusset plate welded joint after 12.5Mcycles loading under $\Delta\sigma = 51\text{MPa}$ and 5.1Mcycles loading under $\Delta\sigma = 62\text{MPa}$. The fatigue strength of this type of web gusset welded joint with fillet satisfies JRA Fatigue Category E which is two-rank higher than that of web gusset welded joint without fillet.
