Structural safety: lessons from the partial collapse of a multi-story car park

JOOST WALRAVEN

Abstract: At 27th of May 2017 a large part of a new multistory car park at the Airport of Eindhoven in The Netherlands collapsed. This collapse occurred a few weeks before the official opening. It turned out that the floors of the building were made according to the so-called Bubble Deck system. This consists of precast concrete planks on top of which reinforcement is provided, in combination with polypropylene spheres. This floor system leads to a light and nevertheless stiff floor. In the past the slabs were design to predominantly carry the loads in one direction. In the last decade the system was changed in such a way that it could carry the load in two principal directions. However, the joints were detailed incorrectly, which resulted in the collapse. It was remarkable that in the 15 years that this detail was used, nobody was aware of the risk of its application. That implies that many other existing buildings might be unsafe as well. In this paper the consequences and solutions are treated.

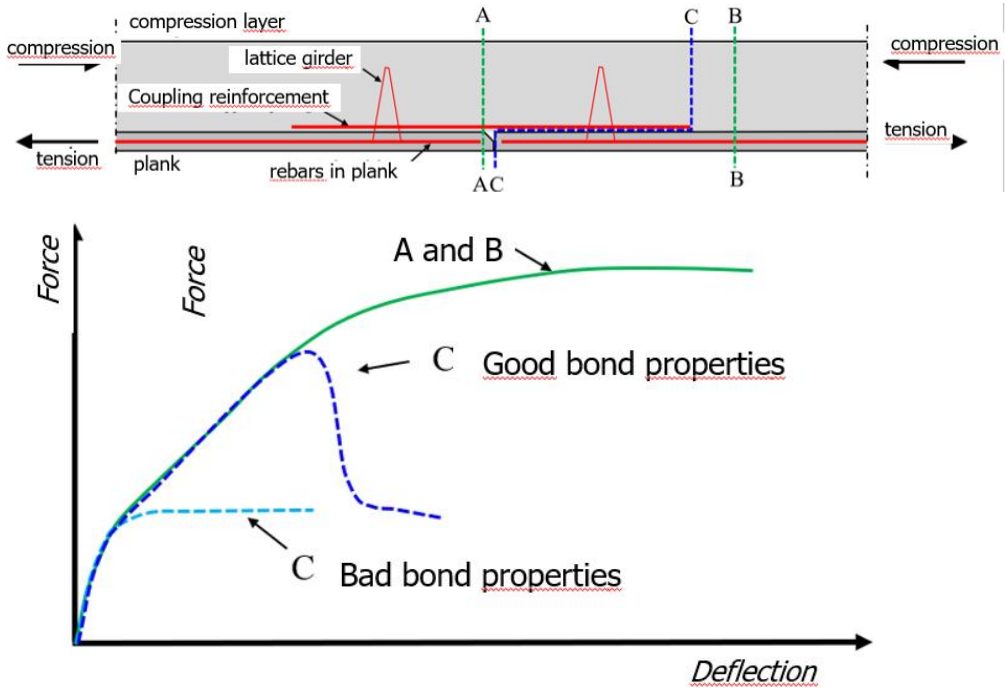
The floor in the parking garage was designed in such a way that most elements were spanning in the direction perpendicular to the longitudinal joints. This required both bending moments and shear forces to be transmitted across the longitudinal joints. Fig. 4 shows details of the reinforcement in the joints carrying bending moments in perpendicular direction. In this case coupling bars had been placed in the in-situ concrete perpendicular to the bottom joint of the composite precast planks. However, in the case that the joint is cracked (vertical dotted line A in fig. 4), the tensile forces in the coupling reinforcement, due to the bending moments to be transmitted across the joint, have to be introduced into the reinforcement in the precast plank. Those forces have to be transmitted across the interface between the precast and in-situ concrete. So, an important requirement is that the interface between precast and in-situ concrete is able to transmit those tensile forces by in-plane shear. So, the bond properties of the interface between the precast and the in-situ concrete are an essential element in the connection. Indeed insufficient interface-shear capacity turned out to be the major cause of the collapse. This indeed occurred in the floors of the parking garage: the insufficient bond of the interface became governing and failure patterns developed according to the dotted blue line C (fig. 4).

Fig. 4. Load-deflection relations (schematic) for the critical detail in case of failure by yielding of the coupling reinforcement (A), the reinforcement in the precast composited plank (B), and failure along the interface between precast and in-situ concrete with good or bad bond properties (dark blue and light blue dotted relations).

As suggested before, the shear strength of the interface between precast and cast-in-situ concrete appeared to be the “weakest link” in the bearing system. In order to verify this hypothesis tests have been carried out at the laboratory of TU Eindhoven. This showed that indeed in all specimens failure occurred by the formation of a crack in the interface between the precast plank and the cast-in situ concrete (according to crack type C (light blue dotted line) in fig. 4.

Another observation was that the triangulated lattice girders, which act as couplers between the precast and cast in situ concrete (also visible in fig. 4) had an insufficient clamping effect: they were weakly anchored and were positioned too far from the joint. Therefore cracks starting in the joint could progress and open easily without being counteracted by the triangular lattice girders.

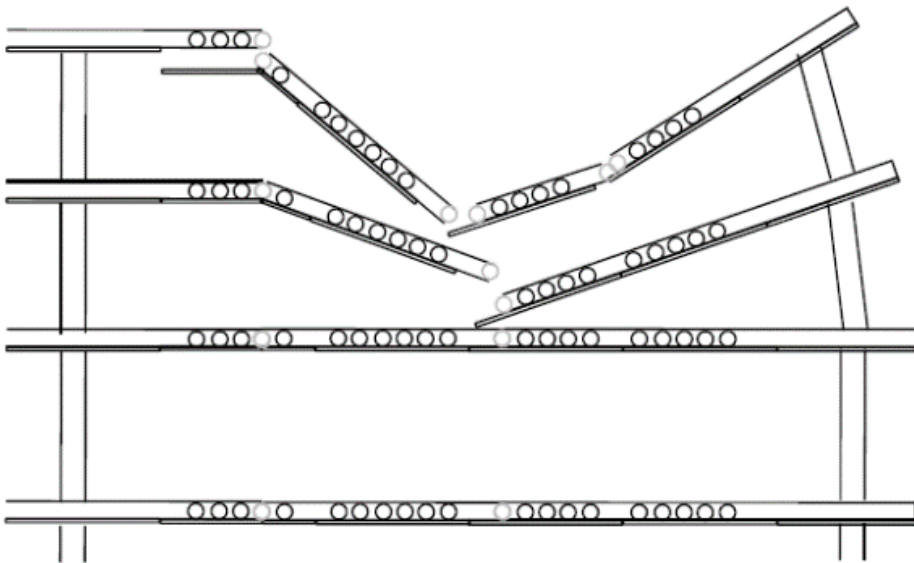
The failure mechanism on a structural level is shown in fig. 5. The first floor which failed was the one on level 4, which led to progressive collapse of the floors on the levels 3 and below.

Fig. 5. Collapse mechanism due to progressive collapse of the floors, starting at level 4.

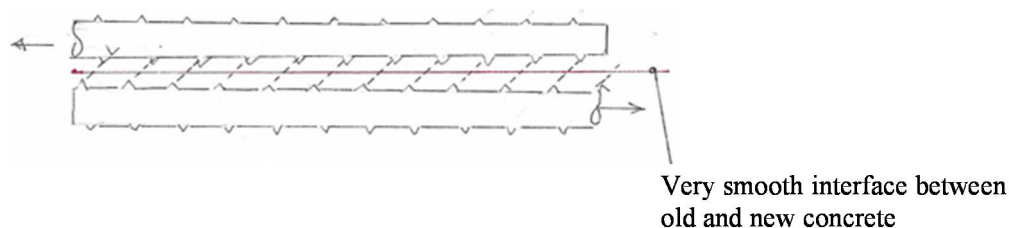
Moreover in section 8.7.2 (1)P it is required that the detailing of laps between bars shall be such that “the transmission of forces from one bar to the next is assured”. In the case considered the lapped bars are positioned in concrete’s cast at different times. The lower bars of any lap are located in the precast plank produced in the factory whereas the upper bars are located in the concrete cast in situ on the top of the plank. So in-between the bars an interface is found, which should be able to transmit the maximum force in any bar from the precast to the cast in-situ concrete (fig. 7).

Fig. 7. Lapped splice with low capacity due to very smooth interface between old and new concrete.

The interface shear capacity of a plane between old and new concrete should be checked with section 6.2.5 “Shear resistance in the interface of concretes cast at different ages”. This check was, however, not carried out. If this verification would have been carried out, the interface should have been qualified as “smooth”, because the plank surface was not roughened after casting in the factory. Tests at TU Eindhoven showed however that in reality

the interface should be better described as “very smooth”, because of the combination of an unroughened surface of the precast concrete and the use of self-compacting concrete for the in-situ layer. The low tensile capacity of the interface was confirmed by tensile tests on vertically drilled cores.

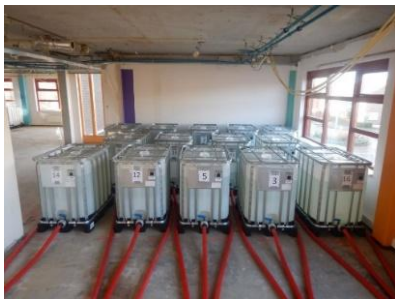
Fig. 8a. Proof loading of a floor of an office in Leidschendam, Netherlands.

Fig. 8a shows proof loading of an office in Leidschendam, the Netherlands, where a floor with the critical detail was investigated. All adjacent floors were loaded simultaneously. The proof loading was carried out with water-containers. In order to make sure that failure of the floor would not damage the remainder of the structure a safety frame was built with 15mm free space to allow free deflection of the floor during proof loading (fig. 8b). The floor was loaded in steps. The following measurements were done:

By the proof-loading up to this level it was shown that the office floors were stronger than derived on the basis of the governing code rules, so no strengthening measures were necessary.

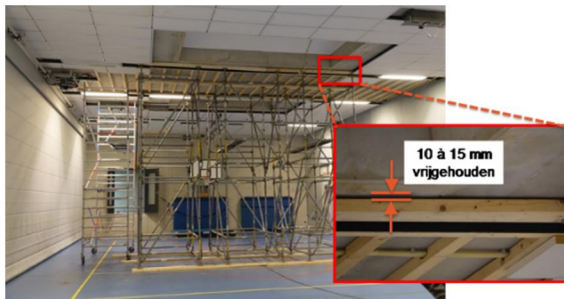
Fig. 8b. Safety frame below floor with 15 mm free deflection.
