STRUCTURAL FAILURES VADEMECUM 2022

STRUCTURAL FAILURES 2022 VADEMECUM AWARIE BUDOWLANE 2022

MONOGRAPH

prevention diagnostics repairs reconstructions

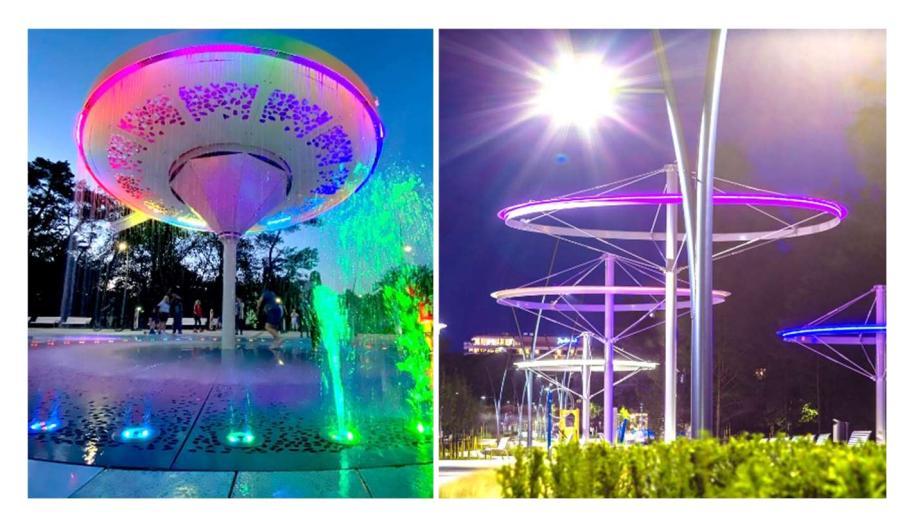
Fig. 1. Steel structures discussed in the article. [source: Internet]

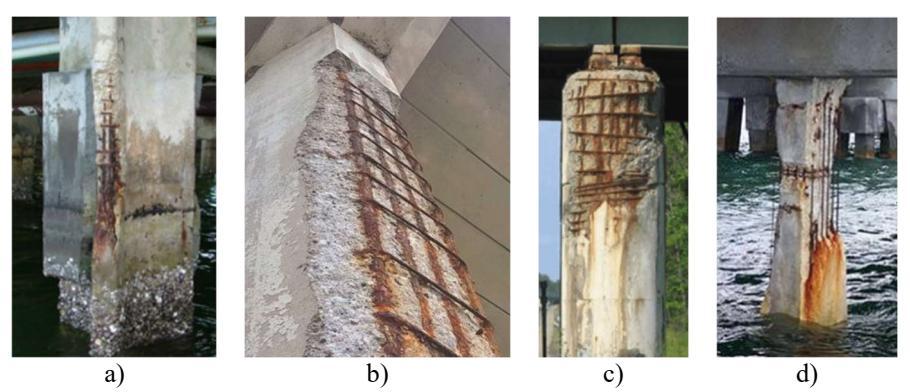
Fig. 1. Corrosion damage to reinforced concrete columns

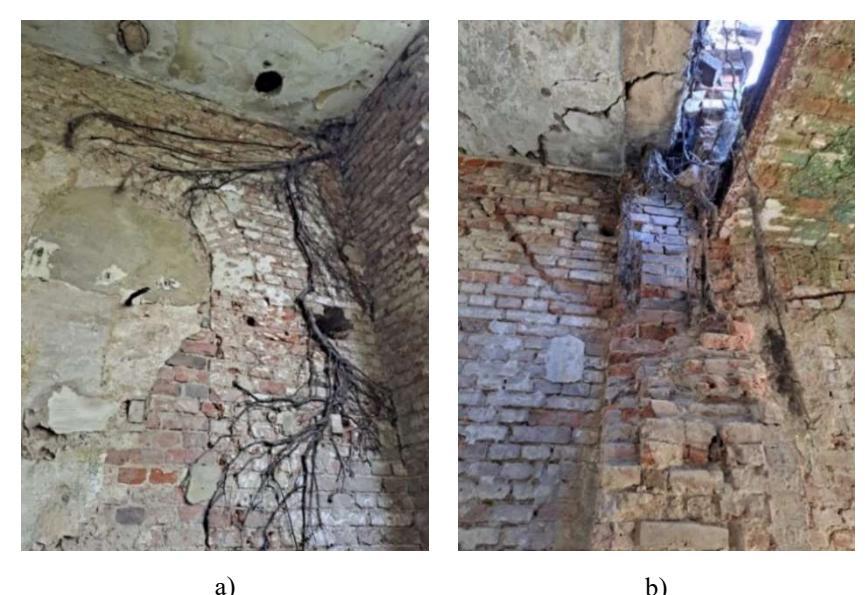
The biggest surprise was the attack of vegetation on the abandoned and devastated walls of the former industrial buildings. Initial examination revealed a typical wall covering with vegetation. However, what was

surprising was the scale of damage caused by the root systems. In some places, the wall was delaminated and detached due to the roots (see Figures 3 and 4).

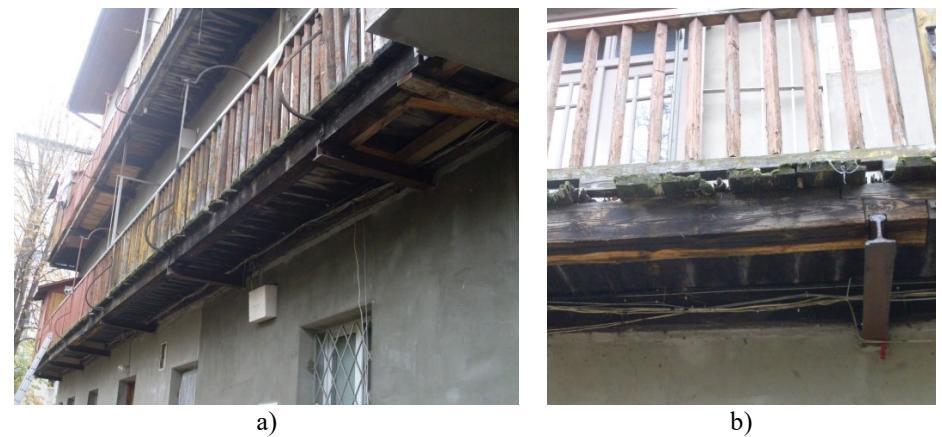
The galleries with a steel and timber structure in a building erected at the beginning of the 20th century were in the worst technical condition (gallery G1 in Fig. 1). Due to the poor technical condition of the timber elements (beams and balustrades), it was recommended to exclude them from use and proceed with immediate repairs. A new structural system was proposed. For conservation reasons, some original elements of the balconies, such as steel cantilever beams and steel elements of balustrades, have been preserved.

Fig. 1. Technical condition of galleries with a) steel and b) timber structure (G1)

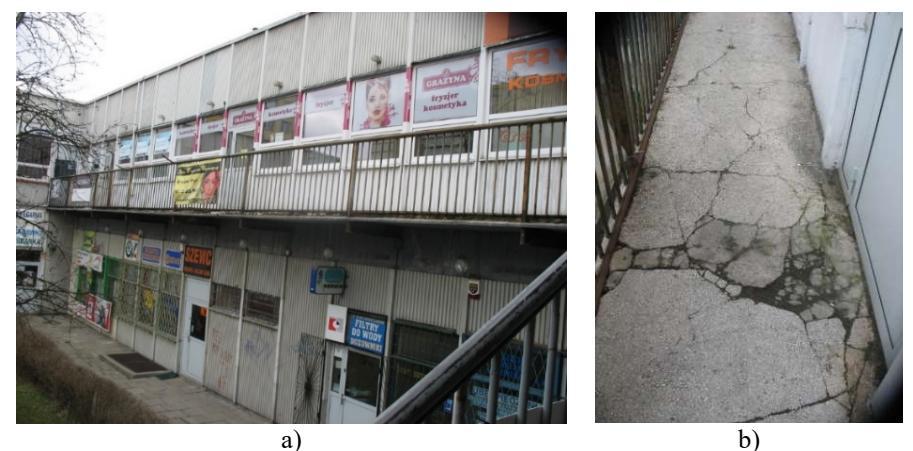
Fig. 2. Damages to galleries with a) steel and b) concrete structures (G2)

reduce the service loads and ultimately perform a general renovation of the galleries. The proposed solution included strengthening the balcony structure and replacing the balcony layers.

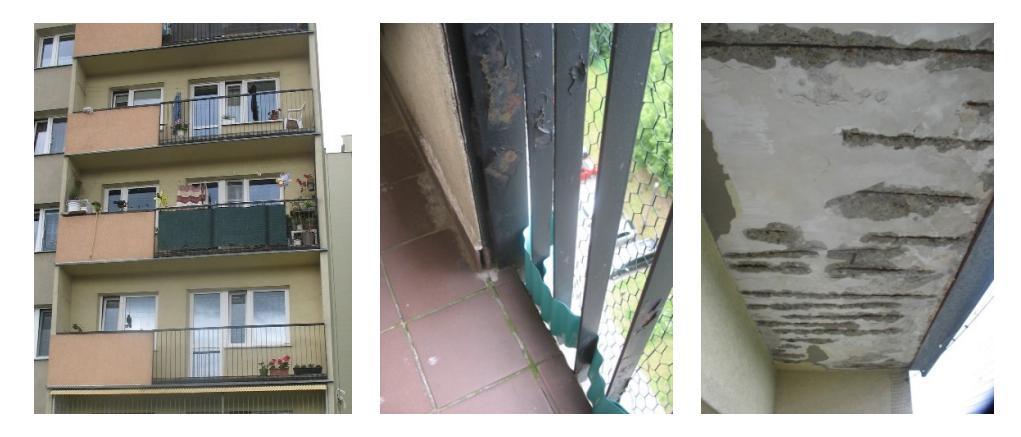
The cantilever balconies in residential buildings that had been in use for over 40 years were also in poor technical condition (balconies B1 in Fig. 3). These balconies were made as prefabricated reinforced concrete elements. In in-situ tests, no waterproofing layers were found. The temporary renovation of balconies carried out in the past was limited to the implementation of new top layers on the existing layers, which led to an additional load on the structure. It was recommended to remove all existing top layers and install new ones in accordance with modern materials and technological systems. Repair of the reinforced concrete slabs of the balconies was also recommended. Until the renovation is carried out, the permissible service load on the balconies has been limited.

Fig. 3. View of the balconies in residential building with prefabricated structure (B1)

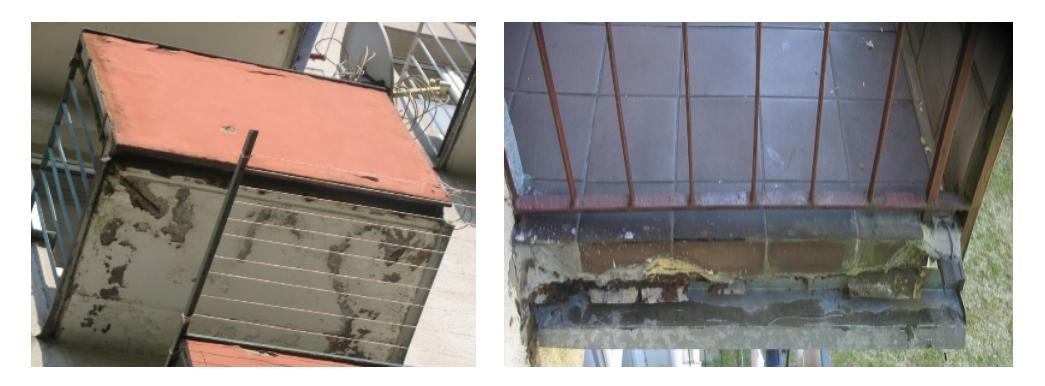
Fig. 4. Damages to prefabricated balconies (B2)

Renovation was recommended, consisting of removing the balustrades and all layers above and below the prefabricated reinforced concrete slabs, and then installing new balustrades and layers.

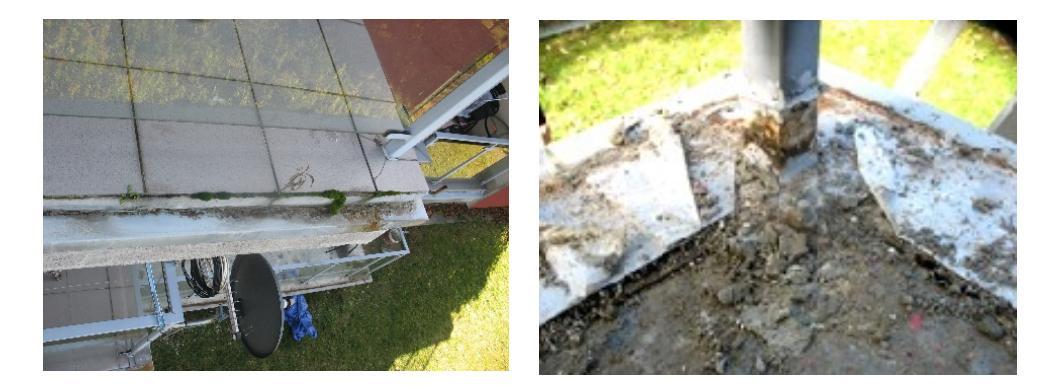
Leaks were visible on the underside of the balconies. During the tests, poor workmanship was identified. The balconies were not constructed in accordance with the design specifications. The waterproofing and flashings were improperly executed, which resulted in material deterioration and detachment of the top layers. Consequently, the balconies were qualified for renovation after only several years of use.

Fig. 5. Damages to balconies in building used for 6 years (B2)

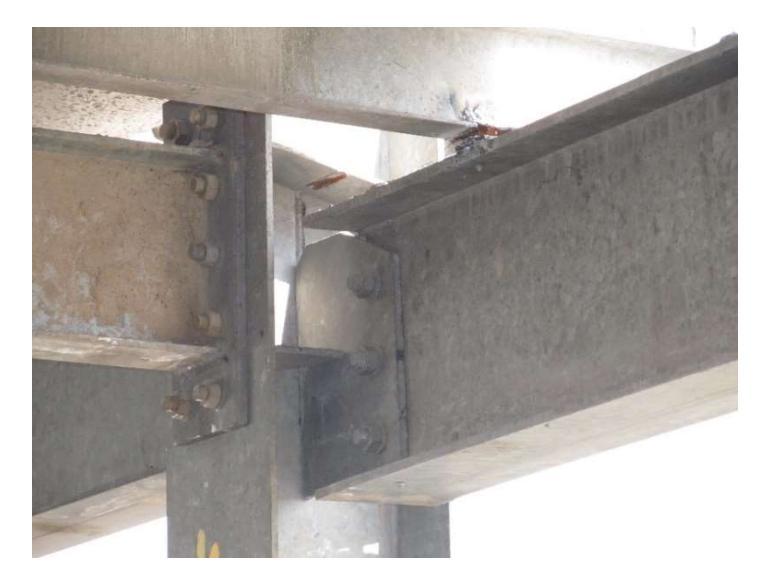
Fig. 2. View of the broken nod at the ceiling level of the 5th storey (axis 3 and front axis A)

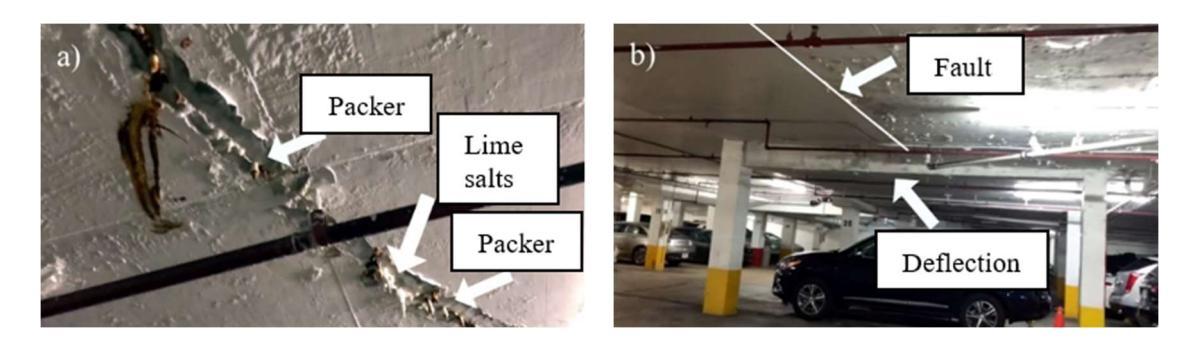
Fig. 8. Ceiling damage. Source: [11] a) close-up of a crack, b) view of the ceiling in the failure zone

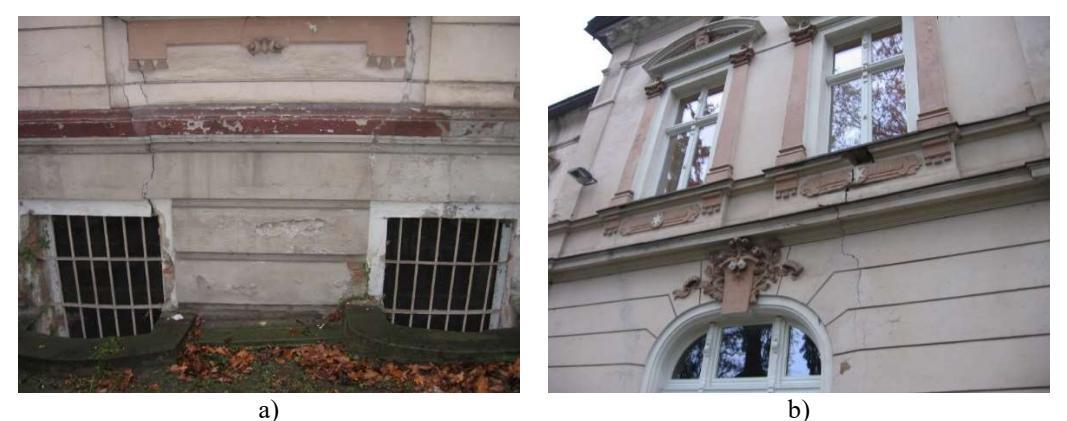
Fig. 3. Fragment of vertical cracks a) on both sides of the ground floor window opening ,b) to the eaves on the south-east elevation

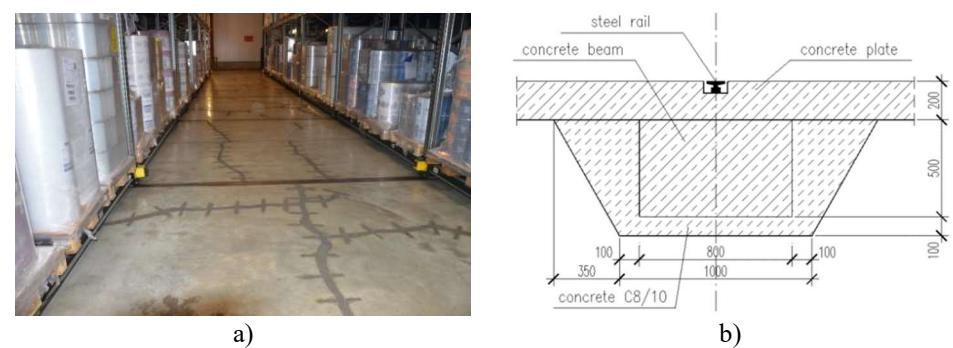
Fig. 1. View of: a) mobile racks and cracks on the warehouse floor surface, b) cross-section of the floor structure

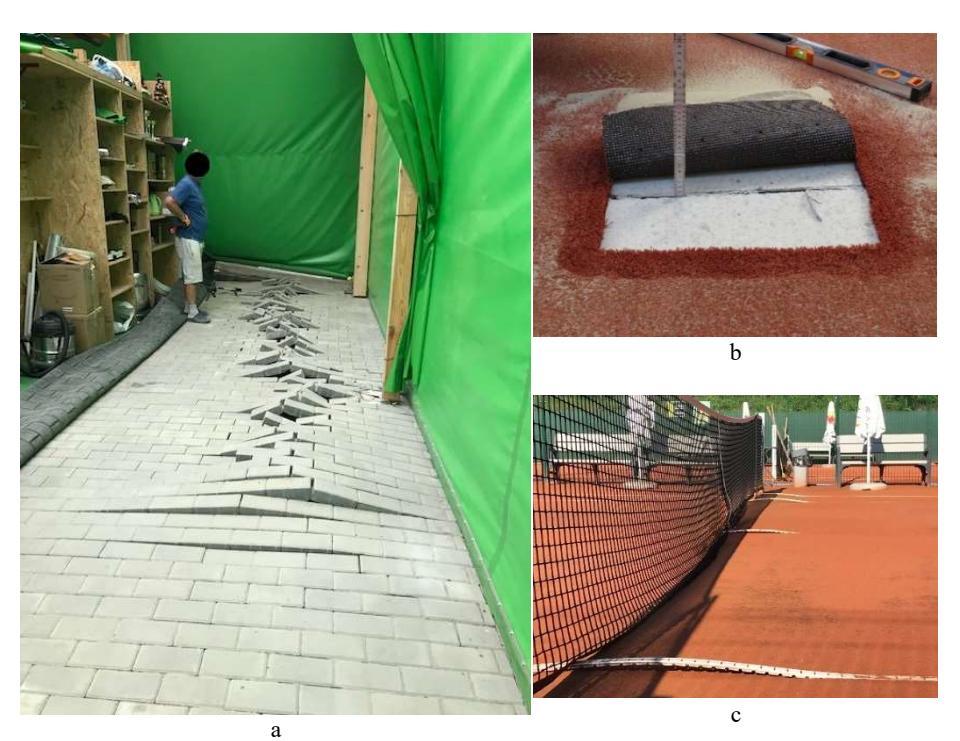
In addition to the damages to the load-bearing frames, other identified damages included: damages of concrete floor inside hall (Fig. 3b), deformation of the surface of the outdoor courts (Fig. 3c) and paving stones (Fig. 3a).

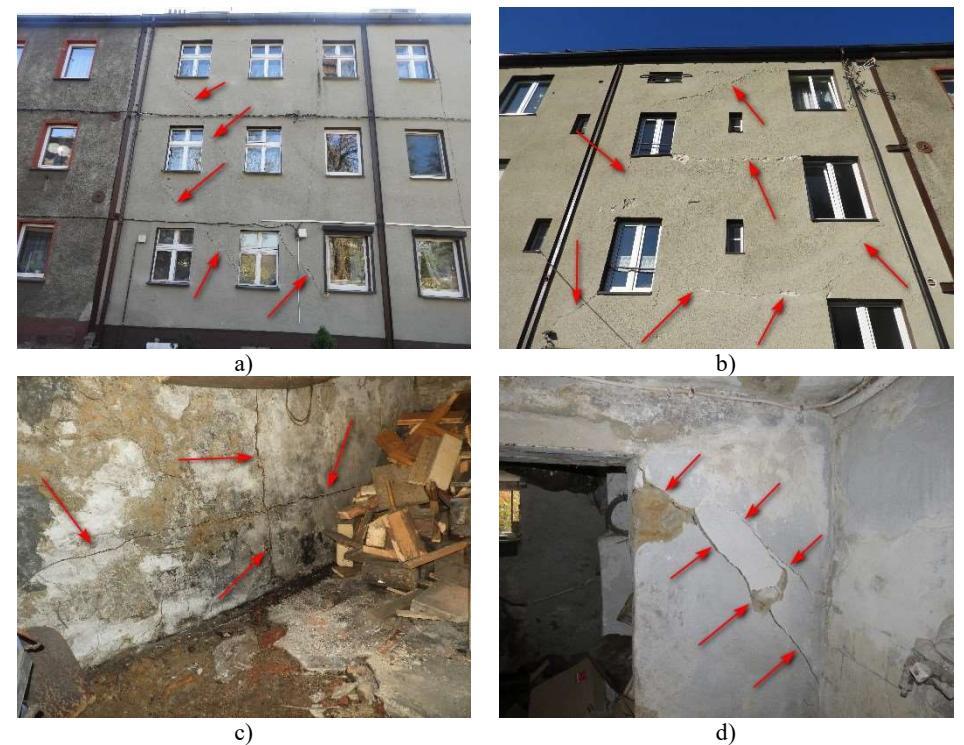
Fig. 2. Damages to the building: a) cross-cracks in the lintel, sill and inter-window strips of the northern wall, b) cross-cracks in the lintel, sill and inter-window strips of the southern wall, c) vertical and horizontal cracks and pushing into the building interior, the western gable wall on the basement floor, d) cracks in the longitudinal wall in the basement

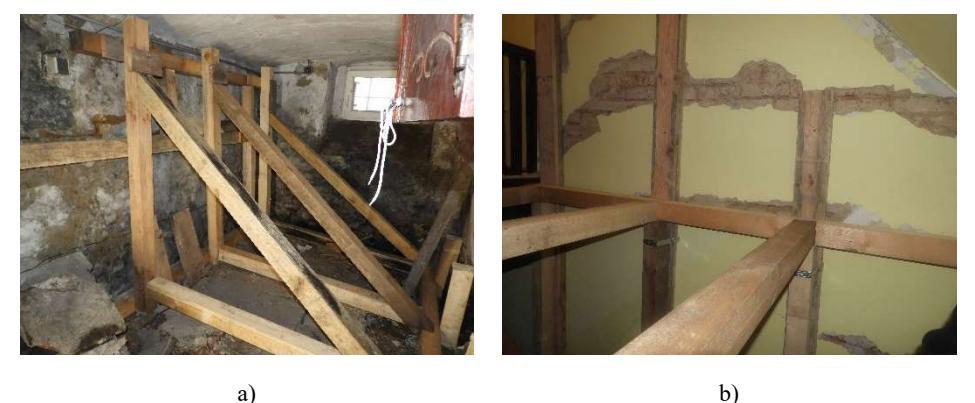
Fig. 3. Temporary support: a) of the western gable wall, cracked and moved inside the building, b) of the staircase wall in the attic level

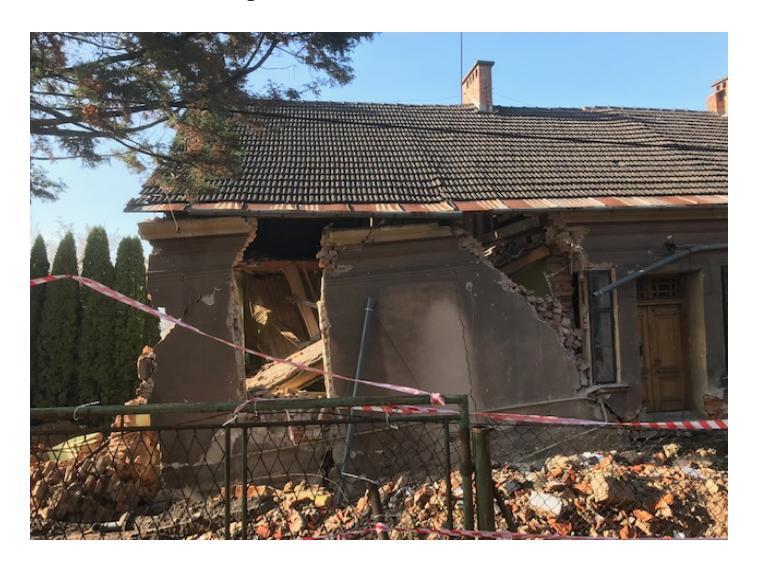
Fig.1. The view of the building partly collapsed.

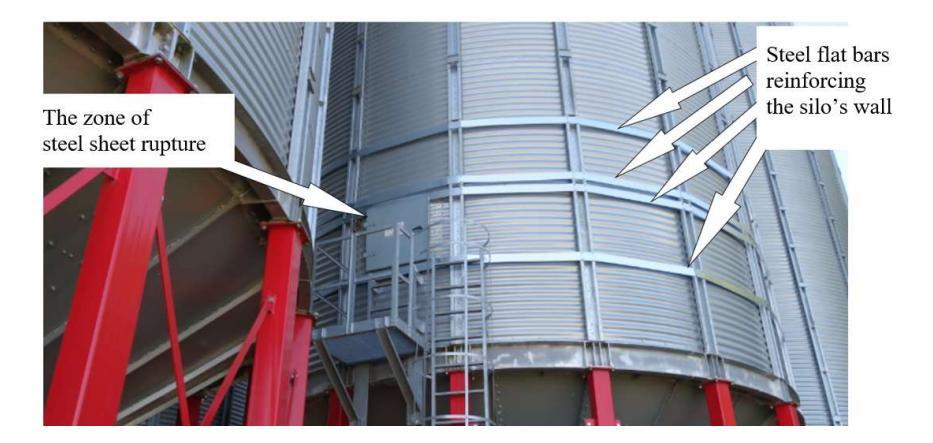
Fig. 1. The view of the lower part of damaged silo

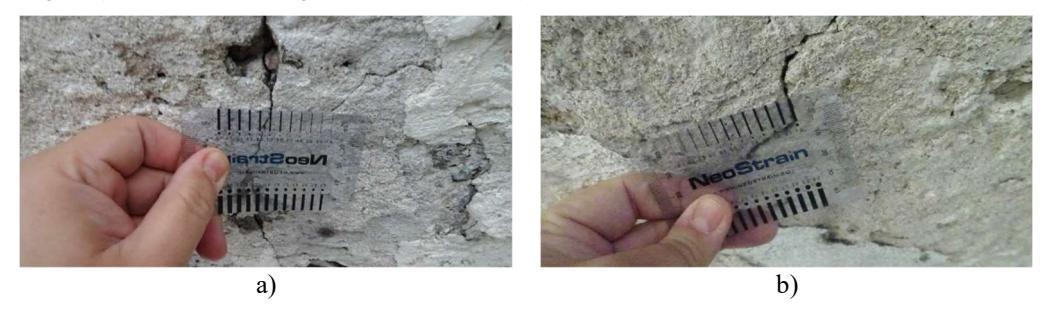
Fig. 2. Measurement of the crack width in the slab above the second a) crack width 1.0 mm b) crack width 1.2 mm.

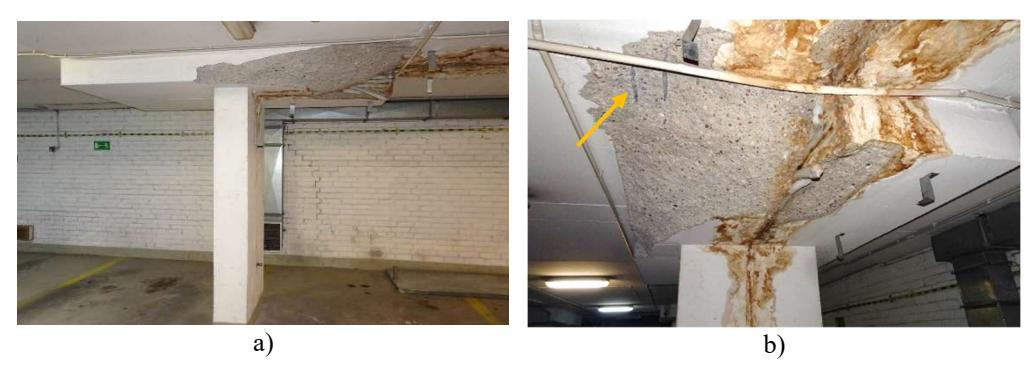
Fig. 3 View of the damage site a) front view b) side view, the arrow marks the bottom reinforcement of the slab

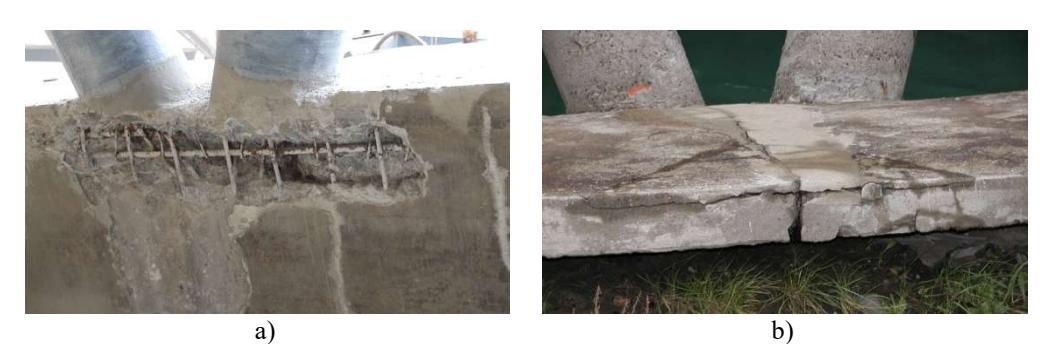
Fig. 1. Typical damage to: a) the basin wall, b) the drip zone

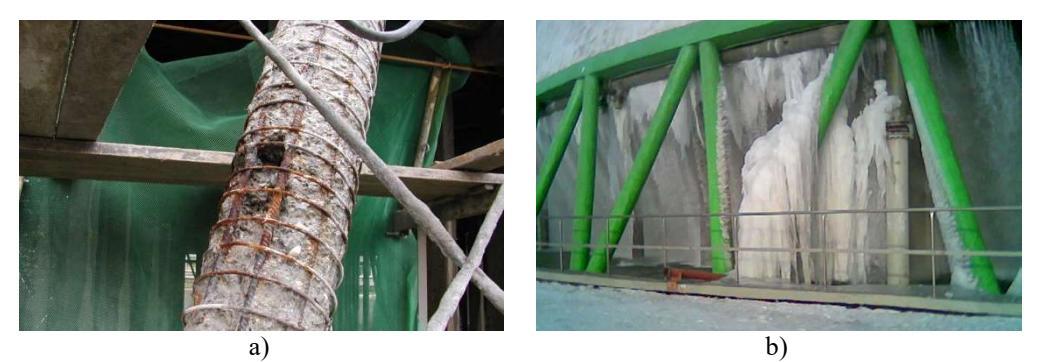
Fig. 2. a) column made of poor-quality concrete, b) iced columns

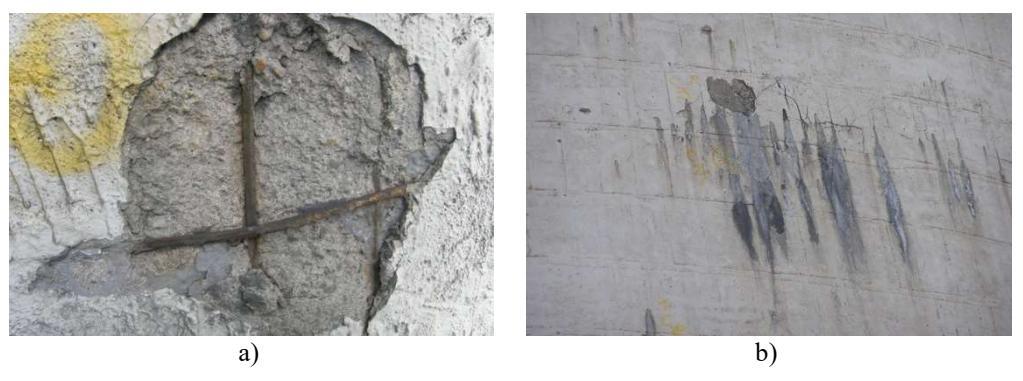
Fig. 3. A) reinforcement corrosion and falling-off cover, b) water leaks

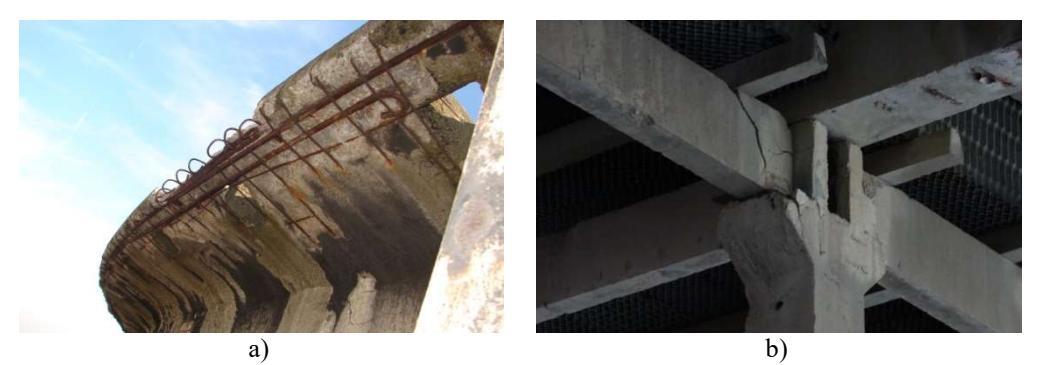
Fig. 4. a) corrosion of the walkway, b) damage to internal elements

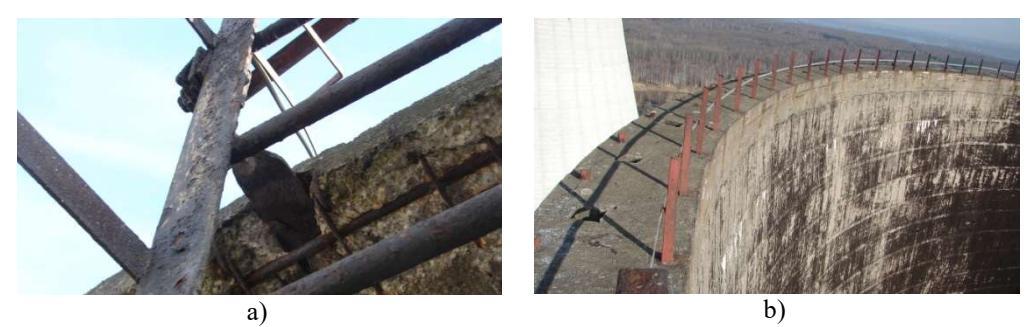
Fig. 5. Corrosion of the ladder (left), and removal of a corroded guardrail (right)

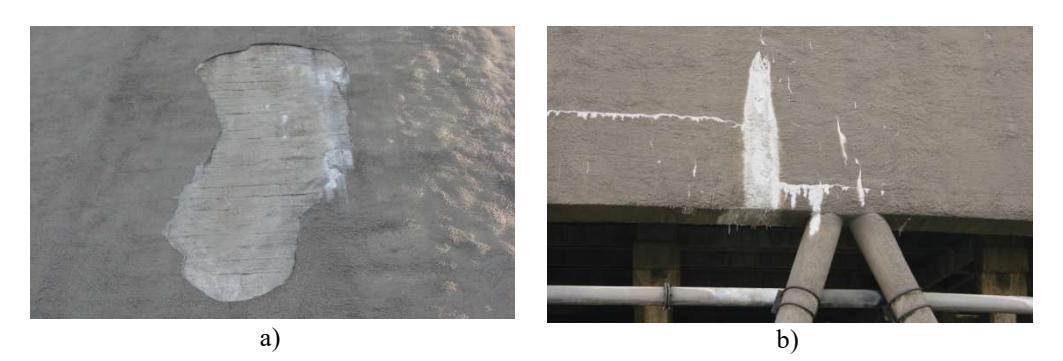
Fig. 6. Shotcrete coming off (left), and water leaks from underneath the concrete (right)

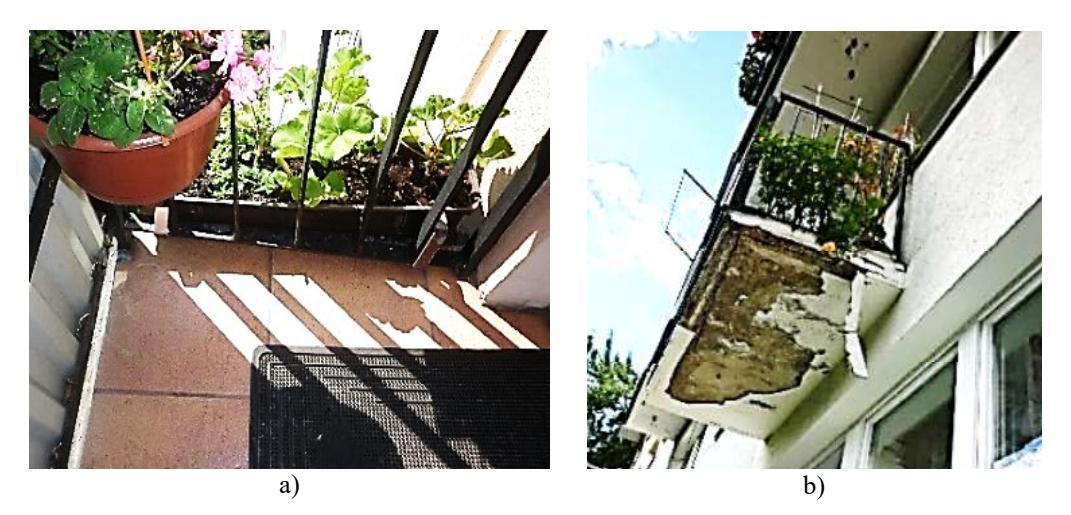
Fig. 1. Balconies in a large-panel building in OWT-67 system: a) general view of balcony after two current repairs and one major repair with ceramic cladding, b) balcony - bottom of the balcony slab, peeling and losses after the third repair (major repair), despite the execution of the ceramic cladding from above.

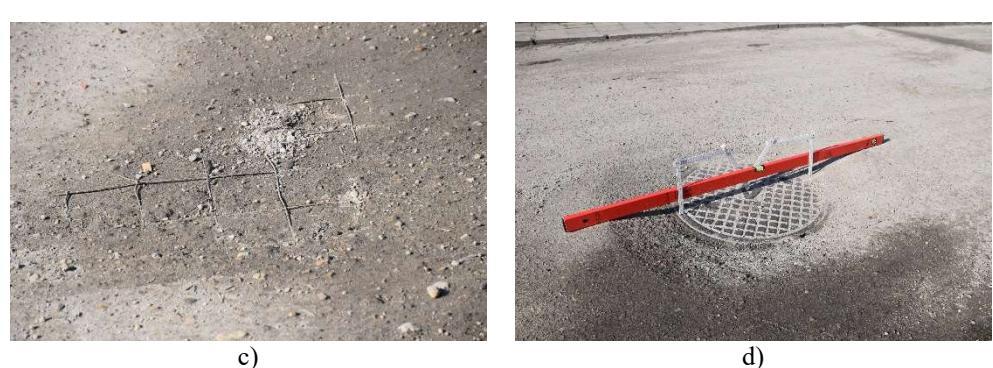
Fig. 1. Pavement damage: a) pavement degradation, b) damaged to pavement texture, c) exposed steel mesh, d) 6 cm undersized manhole cover

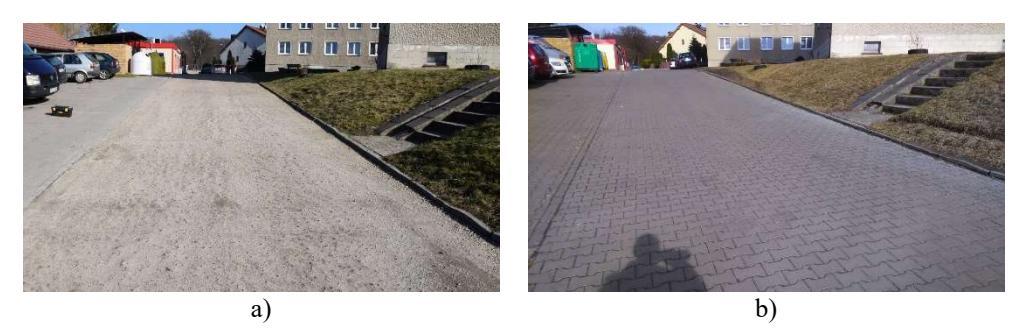
Fig. 2a) view of the damaged concrete pavement, b) pavement after the repair

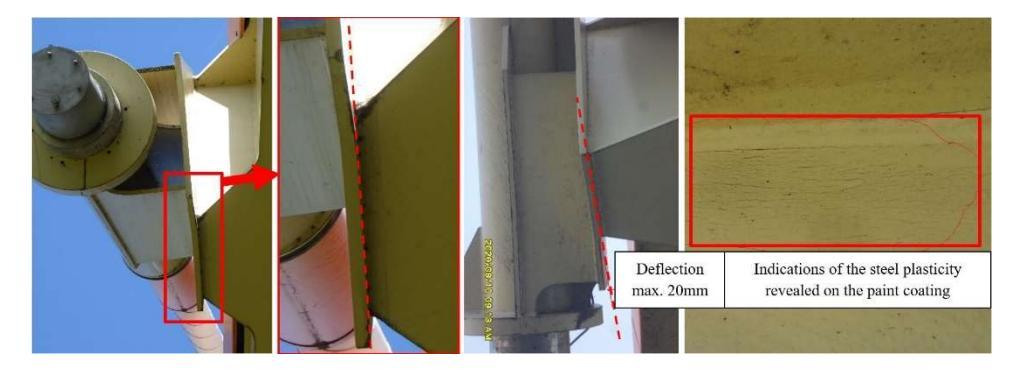
Fig. 3. Examples of deformed plates of cable anchorages and signs of overload
