STRUCTURAL FAILURES VADEMECUM 2022

STRUCTURAL FAILURES 2022 VADEMECUM AWARIE BUDOWLANE 2022

MONOGRAPH

prevention diagnostics repairs reconstructions

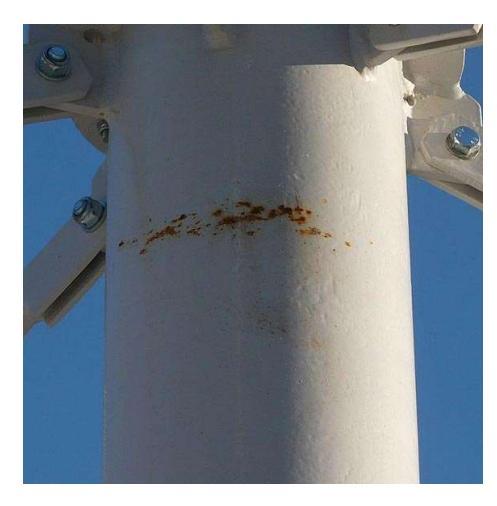
Improperly applied anti-corrosion protection for structures can lead to the first signs of corrosion appearing very shortly after the construction is completed. Such a situation occurred in Świnoujście, where the steel structural elements decorating the promenade showed signs of corrosion despite being recently constructed. The first reports of corrosion problems with these steel elements emerged just a few months after the construction was completed. This indicates both poor quality of the anti-corrosion protections and the high aggressiveness of the environment - see Fig. 2.

Fig. 2. Corrosion of steel elements at the investment site [Source: https://iswinoujscie.pl/artykuly/60923/]

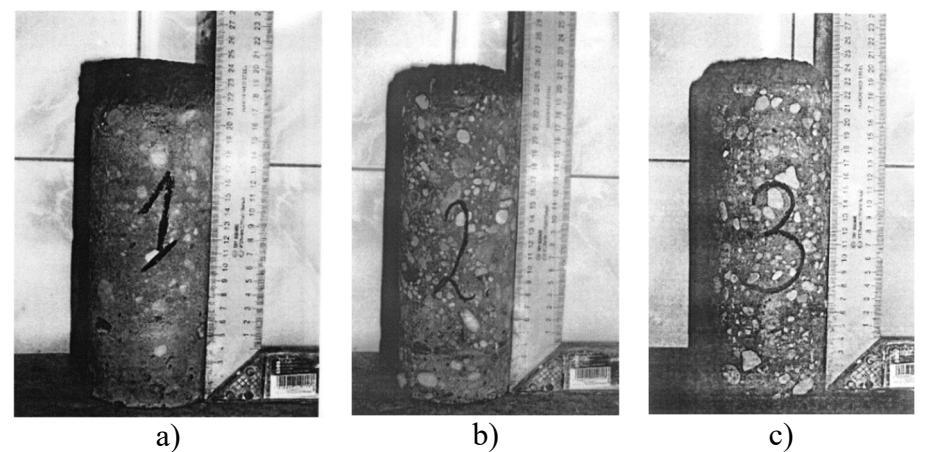
After inspecting the boreholes (Fig. 2), the presence of a frozen upper layer of concrete, 1.5 to 2 cm thick, was found. Importantly, the top reinforcement bars were below the frozen zone. Visual inspection of the boreholes revealed that the upper zone contained microdefects (microcracks, surface roughness) due to frost damage. Such defects were not found in the lower part of the cores, confirming that the concrete did not freeze from the lower surface of the ceiling. Before laying the mix in the formwork, it was additionally heated from the bottom for about 4 hours to remove the residual snow and maintain the formwork temperature above 0°C. This limited the temperature gradient effect at the interface between the concrete mix and the formwork, contributing to the prevention of freezing of the lower, tensioned surface of the ceiling and reduction of unfavorable thermal stresses. After stripping the ceiling and visually inspecting it, no signs of freezing of the lower surface of the concrete, usually identifiable by the naked eye, were found.

Fig. 2. Core boreholes taken from the structure

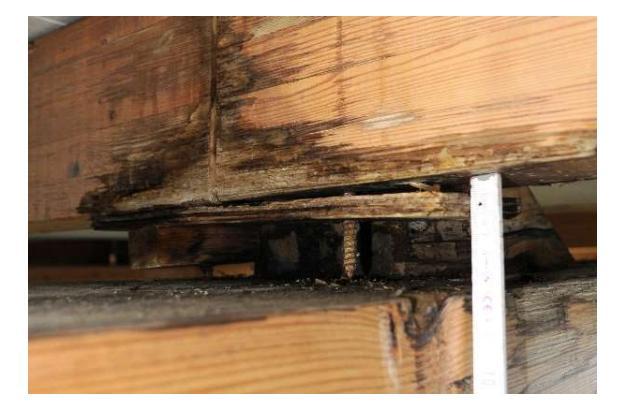
After 20 years of continuous use, the timber roof structures of the swimming pool halls exhibit numerous moisture stains on practically all elements. Deformations in the roof purlins and sandwich panels constituting the roofing have caused the moistening of the timber roof structure.

Water stains on the surfaces of the roof girders and purlins occurred particularly at the joints of the sandwich roof panels. The most intense moisture, covering almost the entire side of the purlins, was found on the roof purlins located in the p, u, d, and h axes, as marked in Fig. 1.

Fig. 3. Pulling out of the screw anchoring the roof purlin to the girder

Stains and moisture were accompanied by the exfoliation of the protective coatings on the wood, graying and blackening of the wood, and the appearance of algae on the surface of the timber purlins in areas with high moisture content. Localized biological corrosion (wood decay) was also found.

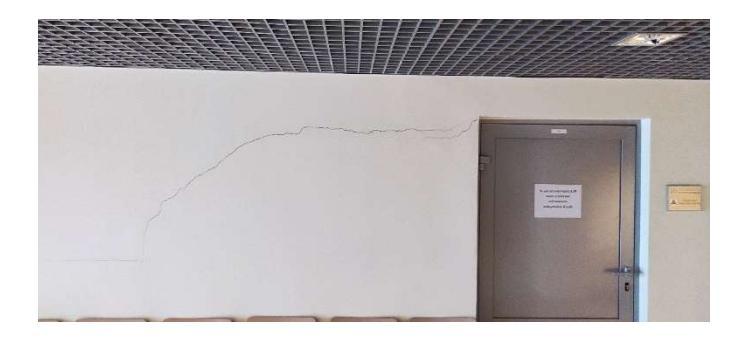
The survey of the partition wall cracking indicated that most of the cracks had a typical pattern related to the excessive deflection of the wall-supporting structure (Figure 1). The course of cracks in the partition walls was heterogeneous, with both vertical cracks and cracks with distinct horizontal and diagonal courses observed. The horizontal cracks usually passed through the bracket welds, whereas the diagonal cracks ran along the bracket and butt welds or through the masonry elements.

Fig. 1. A typical course of partition wall cracking

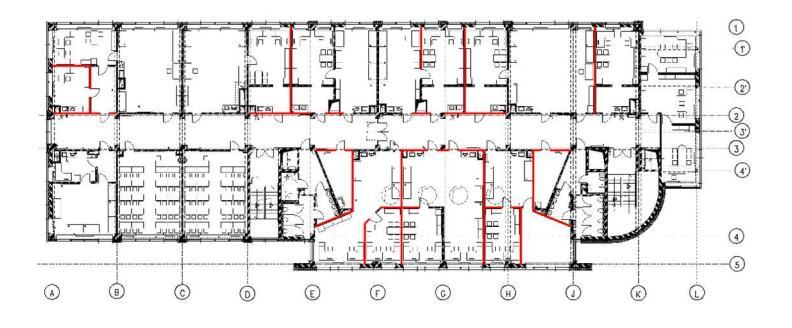
The most pronounced cracks were observed in the partition walls of the rooms and the hallway located above the lecture hall (Figure 2). The crack development in this area ranged from 0.9 to 2.4 mm. The remaining observed crack widths reached 0.3 to 0.6 mm.

Fig. 2. Second-floor plan with an indication of cracked walls

- The most extensive cracking occurred in the area of axes F, G, and H, directly above the lecture hall. The load-bearing system in this part of the building is characterized by the longest spans of construction elements.
- Cracks in transverse partition walls (parallel to the load-bearing frames) appeared when they rested directly on the slabs. Cracking is practically eliminated when transverse walls are supported on beams.
- Cracking of corridor walls was observed in segments connected with transverse partition walls supported on slabs.

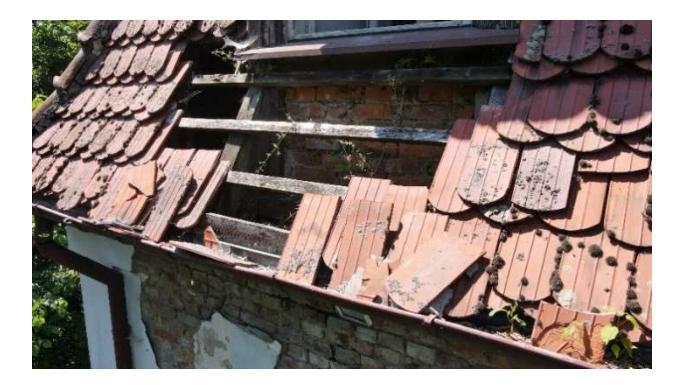
Fig 4. Example of demages - The plants existed in the roof of the palace building near to Poznań

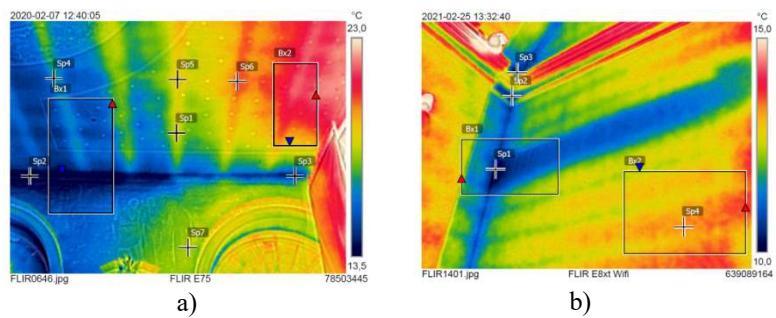
Figure 2 shows exemplary thermograms for wall fragments in the analyzed objects, on the left is the church in Rybna, on the right in Skórzec (newly erected wall - 2012)

Fig. 2. Thermograms of wall fragments with thermal damage

In the opinion of the authors, the thermal imaging analysis of sacred monuments should be supplemented with a numerical analysis of the damage to identify the cause of their occurrence. In both structures, there are clearly visible damages caused by the influence of groundwater and rainwater in the plinth band.

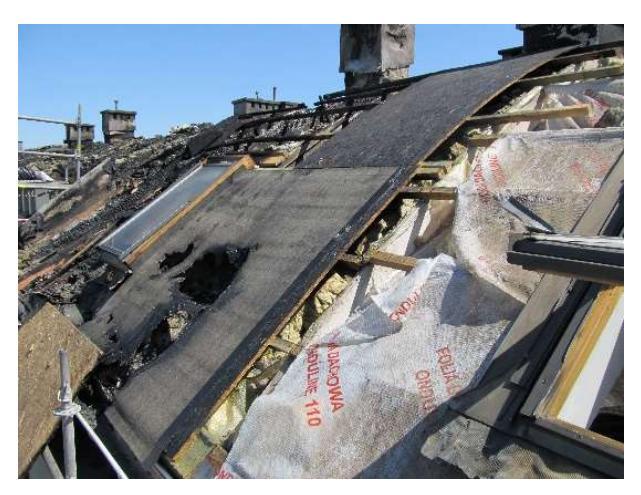
- There was significant damage to the roof covering and the wooden roof structure.
- Rooms of residential premises located at the level of the usable attic were heavily contaminated by elements of the structure and roofing, which ended up inside the building as a result of the fire.
- Most importantly, construction works were performed inconsistently with the building permit design. A significant deviation influencing the occurrence of the fire was the arbitrary change of the mechanical fastening of the base asphalt roofing (permit design solution) to welding of the base asphalt roofing to the OSB boards (Fig. 1).

Fig. 1. View of the weldable asphalt roofing on the primed OSB board (private photo)

Based on the conducted local inspections and the excavations made, it was decided that the roof truss, along with the entire roof covering, needed to be replaced.

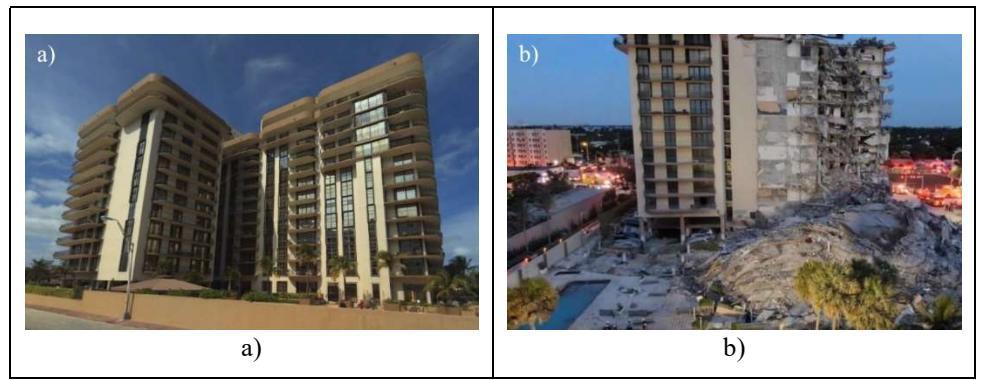
Fig. 1. General view of the building a) in 2015. Source: [2] b) the day after the disaster. Source: [3]

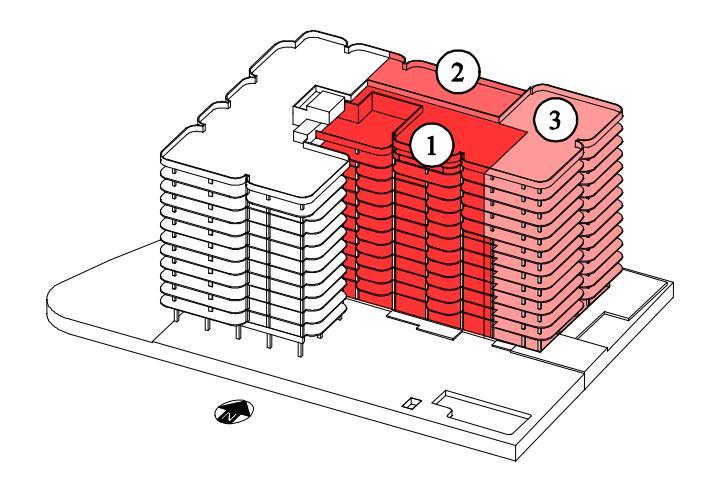
Fig. 2. Axonometric view of the building with the stages of the disaster marked

In the first stage, the central (southern) part of the eastern wing of the building collapsed. All floors above the ground level began to slide down together. There was no observed avalanche effect of the higher floors collapsing onto the lower ones, as was seen in the World Trade Center disaster, which would suggest a failure in the upper parts of the building. After a fraction of a second, the northern part of the building collapsed in the same manner (stage 2). Both parts—the central and northern—separated from the western wing and the remaining eastern section of the building. This was due to the building's design—the division occurred along the edges of the reinforced concrete shear walls. Unfortunately, the remaining eastern part of the building lost stability and collapsed shortly thereafter (stage 3). Similar to the central and northern parts, this section collapsed due to a failure in the lower part of the structure.

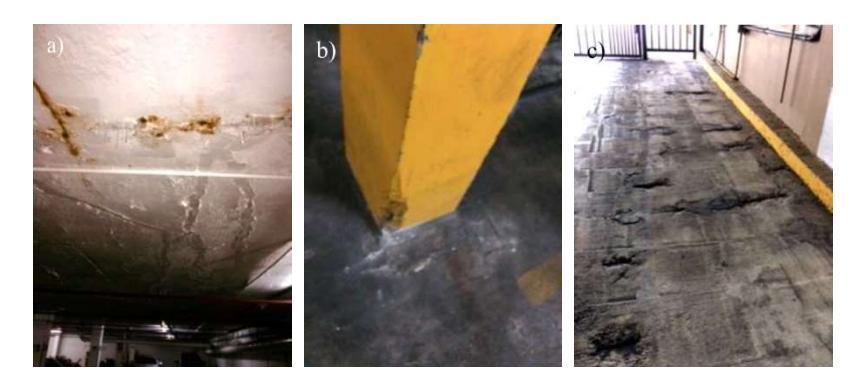
Besides ceiling damage, numerous defects were found on the edges of the columns and severe degradation of the ramp descending to the garage. Examples of these damages are shown in Figure 7.

The numerous, still active leaks through the ceiling cracks led the review author to conclude that the insulation on the ceiling was not watertight. Moreover, it was observed that the slopes on the ceiling were either not made or were too small, leading to the formation of water stagnation.

Fig. 7. Damage to the structure in the underground garage Source: [8,9] a) cracks and rust stains on the lower surface of the ceiling, b) column damage, c) defects in the ramp plate

The author of the studies [8,9] stated that the corrosion spots on the reinforced concrete structure present at that time were local and did not pose a threat to the overall safety of the building, but they required prompt repairs using appropriate techniques such as injection, reprofiling, or filling of voids.

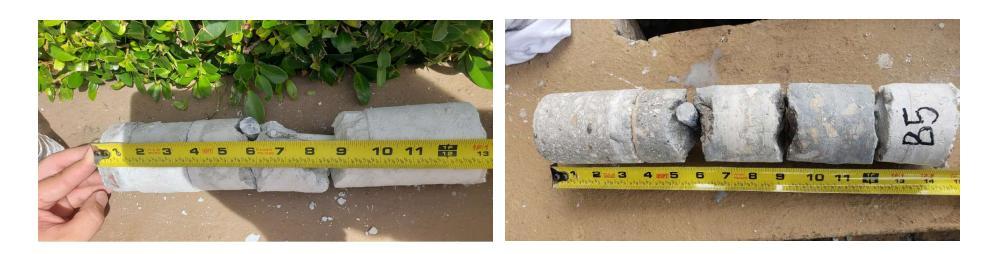
Fig. 9. Views of core samples taken from the garage ceiling. Source: [9]

For the purposes of this study, core samples were taken from the garage ceiling (Fig. 9). Cores were collected from the patio area, the ceiling within the building outline, and the driveway. The condition of the concrete can be considered satisfactory. No rust was found in the samples, but concerns arise from the concrete voids around the reinforcement and the ease with which the rebar can be detached from the concrete. This may indicate reduced adhesion between the reinforcement and the concrete. Based on the recommendations from the reviews [8,9], a comprehensive repair project for the building was developed [10].

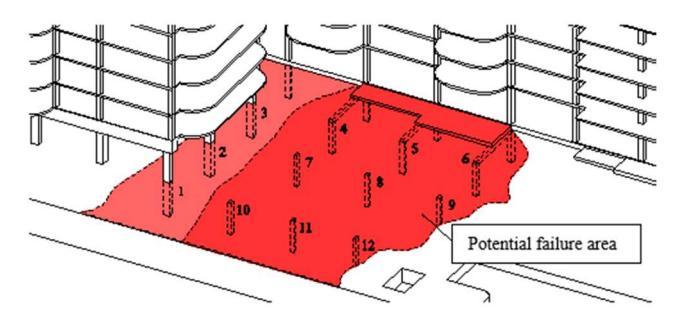
As previously mentioned, just before the collapse of the eastern part, witnesses reported the ceiling above the garage caving in. Figure 10 schematically shows the area of the ceiling failure, and Figure 11 presents photos of the damaged ceiling. It cannot be ruled out that the initial area of failure covered a smaller area (marked in red), and further destruction of the ceiling was caused by the collapse of the above-ground floors of the eastern part of the building.

Fig. 10. Hypothetical area of the ceiling failure above the garage

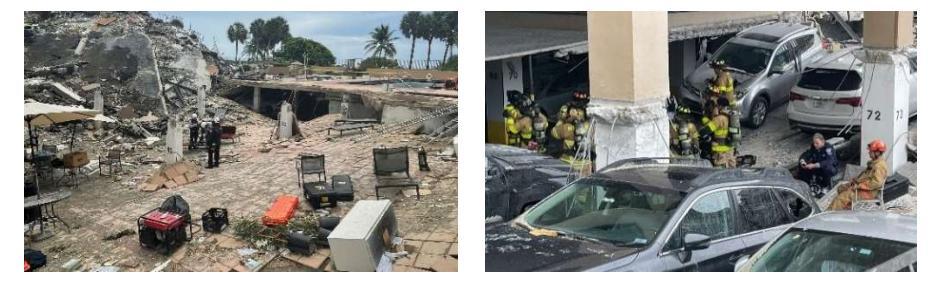
Fig. 11. Collapsed ceiling above the garage - visible effects of the punch-through. Source: [12]

As seen in Fig. 11, in the area of the failure, the ceiling underwent a punch-through on all visible columns regardless of their size. Most of the joints were essentially completely destroyed—this applies to columns with a cross-section of 300×400 mm. In columns with a cross-section of 610×610 mm, which supported the part of the building that survived, partial punch-through cones can be seen, characteristic of eccentric load effects.

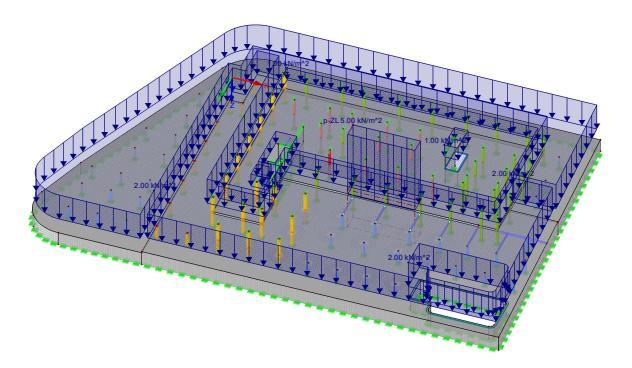
To confirm the hypothesis that the ceiling was destroyed by punch-through, a numerical computational analysis of the ceiling above the garage was conducted. Internal forces in the ceiling were determined using a spatial model. It included floors and vertically cooperating elements—columns and walls (Fig. 12). A finite
element mesh (FEM) of 50 cm size was used, with local densification over the columns. The lower columns and walls were anchored in the foundation. The ends of the upper columns and walls were also anchored, with only the vertical axis sliding allowed.

Fig. 12. Computational model of the ceiling above the garage

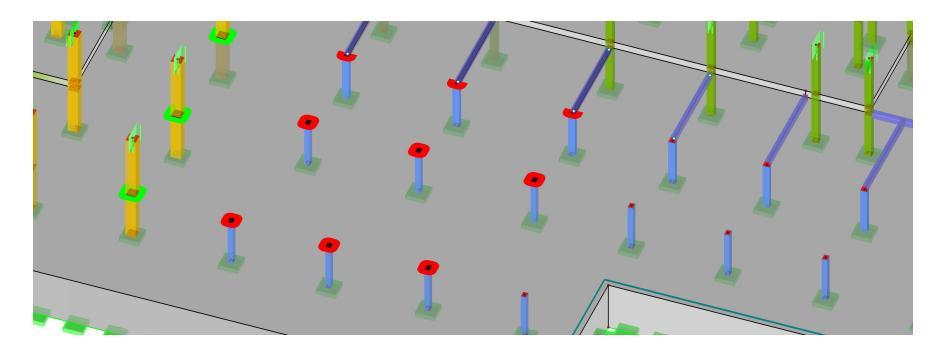
The calculations confirmed that the capacity for punch-through was exceeded even for the permanent load alone, regardless of the standard used. In the case of calculations according to EC2 [7], deficiencies in capacity occur in all zones of column punch-through with a cross-section of 300×400 mm, ranging from 27% to as much as 102%. The areas around columns with a cross-section of 610×610 mm are an exception, where there is a small margin. In the case of calculations according to the ACI 318-77 standard [13], there are also deficiencies in capacity, though they are less severe.

Fig. 13. Graphical presentation of control perimeters according to EC2 [7]. Red color indicates exceeding shear capacity.

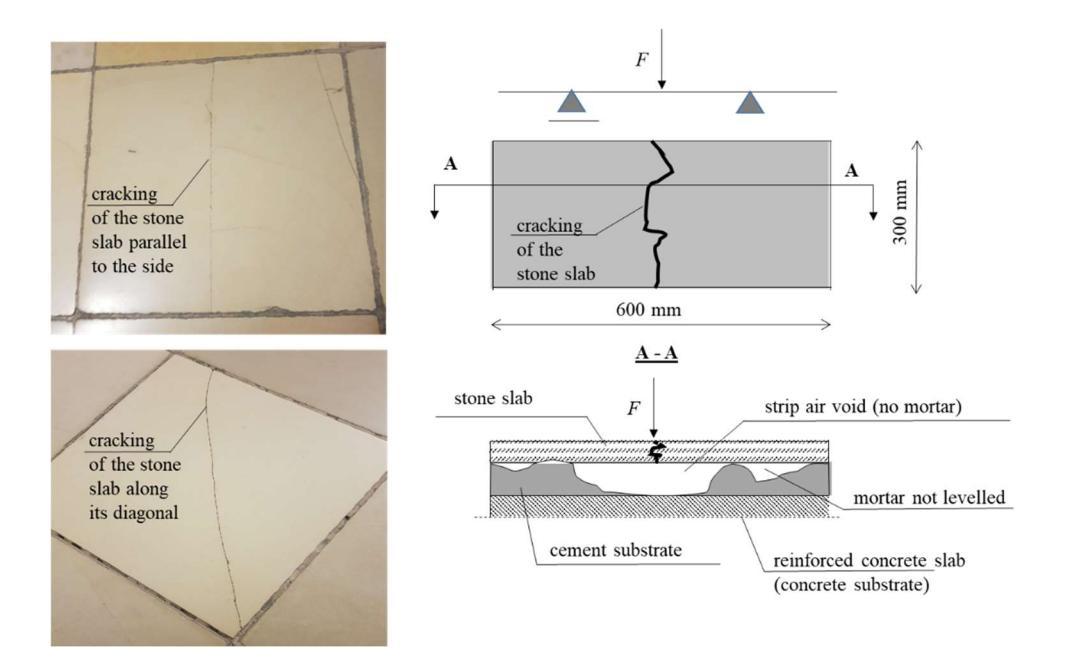
The streaked shortages of cement mortar under the slabs and the lack of leveling are technological irregularities that result in cracking when heavy loads, such as the wheels of an electric trolley loaded with building materials during the finishing stage or goods during operation, drive over these slabs. The mechanism of slab cracking in such situations is illustrated in Fig. 1.

Fig. 1. The mechanism of cracking of stone slabs in exploited floors

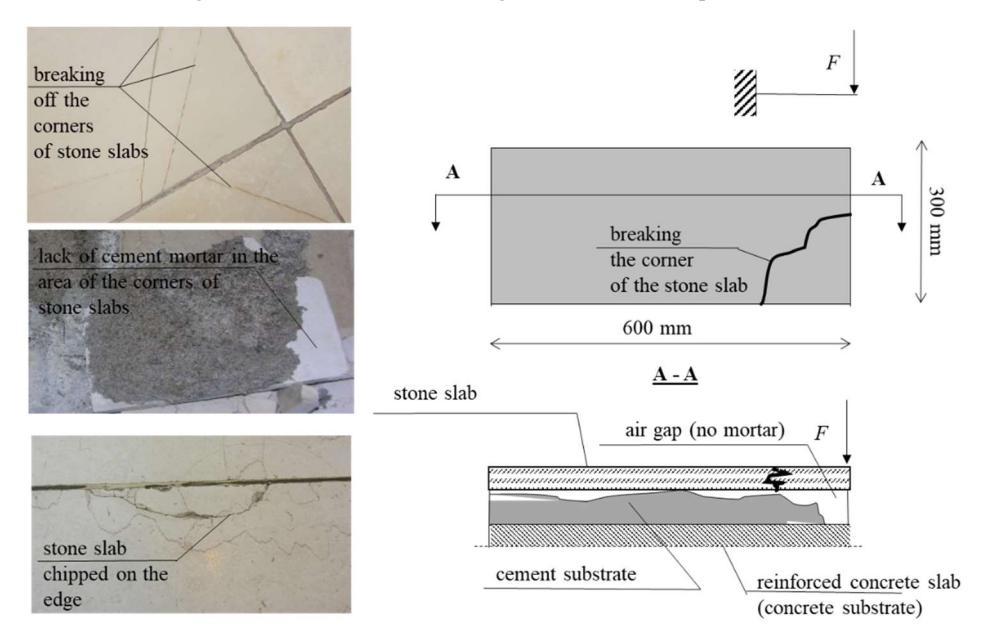
Fig. 2. The mechanism of cracking of stone slabs in exploited large-area floors when there are local deficiencies of cement mortar in the area of corners or edges

The lack of cement mortar in the area of the corners or edges of the slab is another technological irregularity that occurs when the slabs are placed on "spots" of cement mortar. In such cases, the corners become supports that are susceptible to breaking off not only when the wheel of a loaded trolley runs over them but also when they are loaded by scaffolding used for repair and maintenance works. The mechanism of slab corner cracking in these situations is illustrated in Fig. 2.

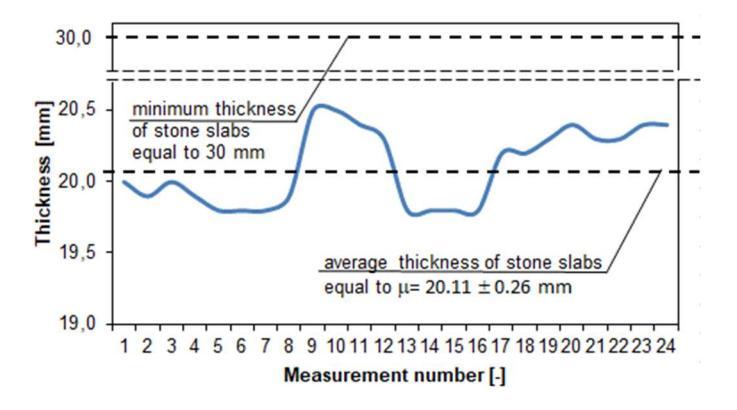
In the event of the above-mentioned performance irregularities, a cumulative cause that increases the susceptibility of stone slabs to cracking may be their thickness being too small compared to the designed specifications. An example of this situation is a large-surface floor with a top layer made of marble slabs, where the design specified a thickness of 30 mm, but this was changed to 20 mm at the execution stage [4]. The results of measuring the thickness of the slabs in this floor are shown in Fig. 3.

Fig. 3. Results of measurement of the thickness of samples of marble stone slabs cut from the floor (own elaboration based on the results of the research published in [4])

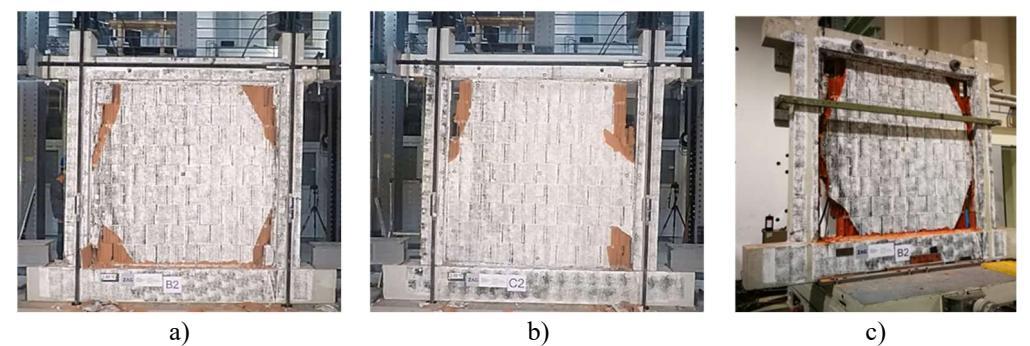
Rys. 2. Damaged frames after in-plane cyclic shear tests: type A (a), type B (b) and the frame type B after the action of outof-plane dynamic harmonic loads in resonance - for 10 minutes (c)

For comparison, the A-type wall completely detached from the frame at a deflection of 0.5%, with edge chipping occurring at 1.6%. There was a risk of the wall falling out of the frame plane. The test was stopped to install the FRPU reinforcement. The A-type frame, reinforced with FRPU, showed a significant increase in load capacity and ductility compared to the damaged A-type frame without FRPU. Moreover, even with significant deflection of the frame after FRPU reinforcement, there was no significant damage that could lead to the wall falling out of the frame plane. This was confirmed by visual inspection after a cyclic test, where attempts to remove the reinforced wall from the reinforced concrete frame were unsuccessful [8].

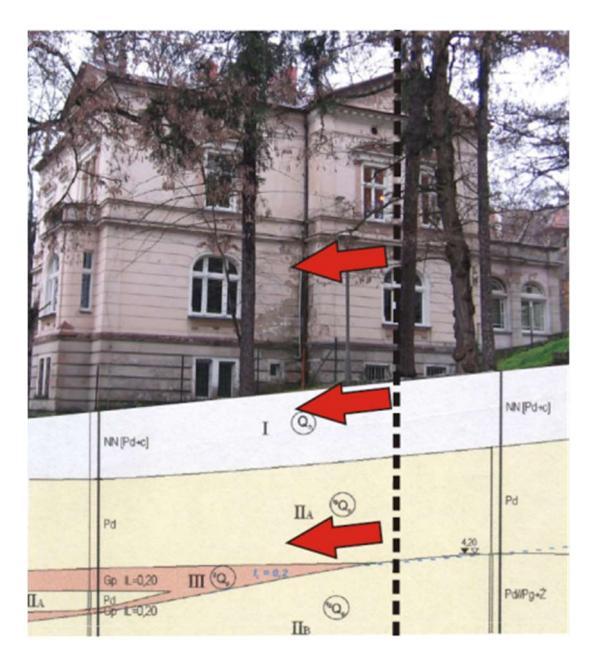
The building is situated on a slope descending from the north-east direction down towards the road. The cracks visible on the north-west and south-east walls are caused by parts of the building moving down the slope in the south-west direction.

Fig. 5. Direction of building displacement

The analysis of geological cross-sections presented in the geotechnical documentation of the building shows that under the foundations, at a depth of approximately 4 meters below ground level, there is a thin (approximately 0.5 meters thick) layer of sandy clay [10]. This layer runs parallel to the slope of the ground in this location. Above it are fine sands, and below it are fine and coarse sands. This geological arrangement causes a slow sliding of the building along with the soil above the clay layer under the influence of the building's pressure in wet conditions. As a result of these movements, clear structural cracks and fissures have appeared on both façades parallel to the direction of the slope, providing evidence of the building's movement. The basement floors also show cracks across the building between the northwest and southeast walls.

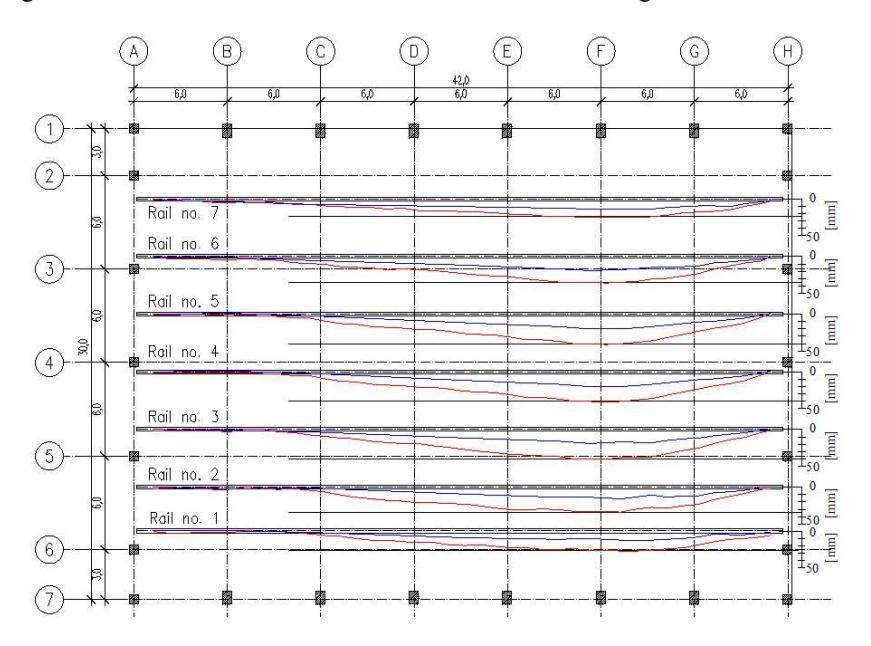
(Fig. 2), resulting in rail inclinations of up to 8 mm/m. Additionally, local inclinations of the floor perpendicular to the rails measured up to 16 mm/m.

Excavation revealed that the floor slab lacked the intended top and bottom reinforcement, having only dispersed reinforcement instead. Furthermore, the main beam of the grid was not covered with concrete, and a 10 cm layer of concrete was placed under the slab. Analysis during the excavation further demonstrated that the bent main beam of the grid was not cracked and was in contact with the soil along its entire base.

Fig. 2. Plots of warehouse floor (steel rails) settlement

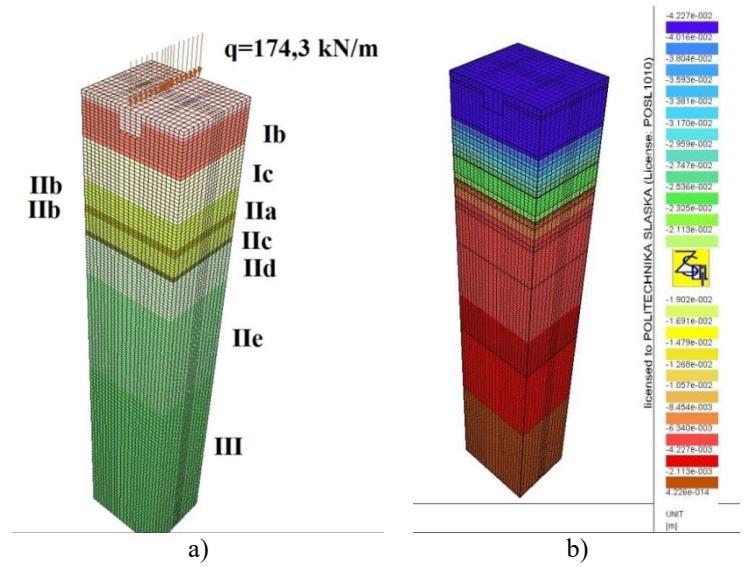
In order to confirm the influence of soil and water conditions on the observed settlement of the floor structure, a numerical spatial analysis was carried out using the finite element method in the Z_Soil software (Fig. 3a).

Fig. 3. Numerical (FEM) model : a) main view, b) maps of vertical settlement

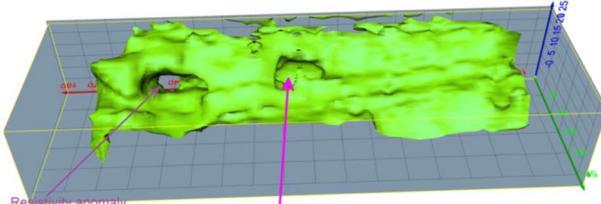
A borehole (9ITB) performed in this area showed a void in the ground at a depth of approximately 15.4-17.3 m b.g.l. After inserting the camera into the hole, it was found that the drilled cavern was a fragment of reinforced concrete tunnels—German shelters from the World War II period. Similar to the boundary described earlier, the boundary between the anomalies was also encountered in the ERT_3 profile along a length of 50 meters. A borehole (12ITB) made in this place showed the presence of a collapsed corridor of the shelter. This was also confirmed in the SRT profile (Fig. 1). A detailed description of these discoveries, along with the documentation of the identified tunnels, is included in the investigation reports [3], [4]. Most of the underground corridors were constructed using the mining method with prefabricated reinforced concrete slabs and beams, measuring approximately 1.9 m high and 1.5 m wide, with local widening and narrowing of the tunnels. By analyzing the type of structure and comparing it with known objects of this type in Szczecin, these tunnels were identified as German tunnels from World War II, serving as shelters (Fig. 2a).

tunnel discovery site Anomaly confirmed with the hole 9ITB

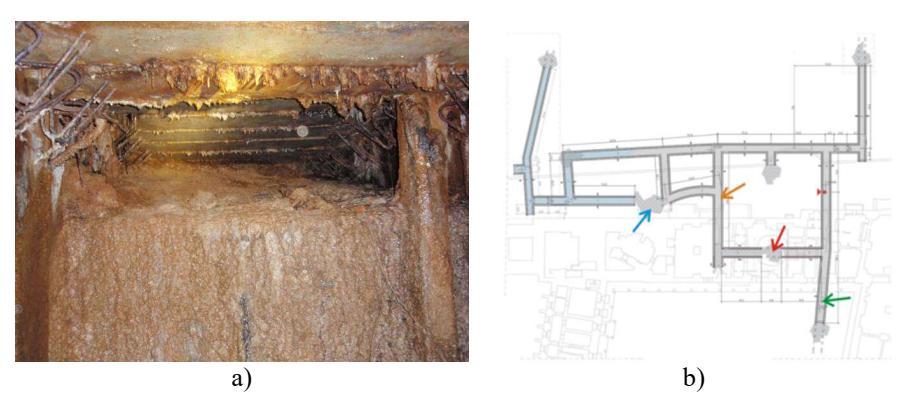
Fig. 3 a) left: the view of the face of the unfinished tunnel under the courtyard (behind the green arrow according to Fig. 3b) – you can see the inflows, b) in the foreground next to (right) the established inventory of tunnels on the basis of direct exploration [7] – the red arrow indicates the site of the disaster and the collapse within the brick tunnel. The others are explained in the text.

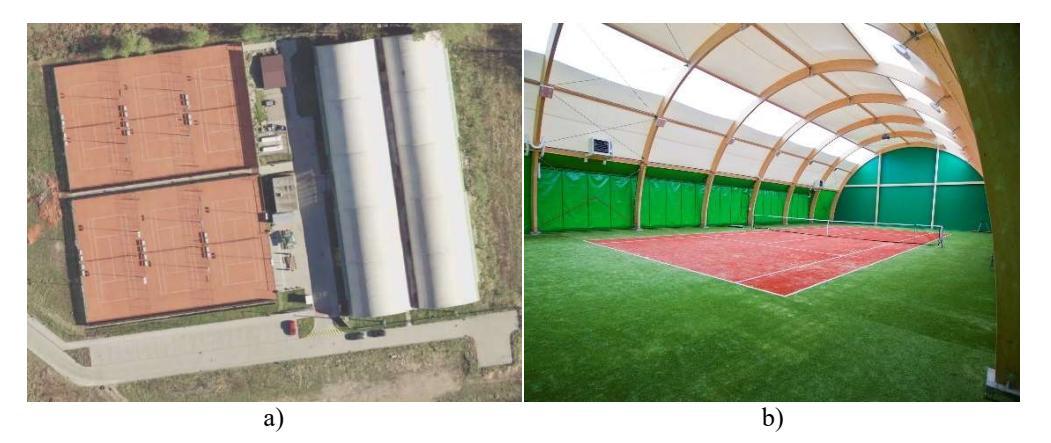
Fig. 1. Buildings of the tennis court complex: a) the hall is located on the right side of the drawing, b) view of the interior of the hall

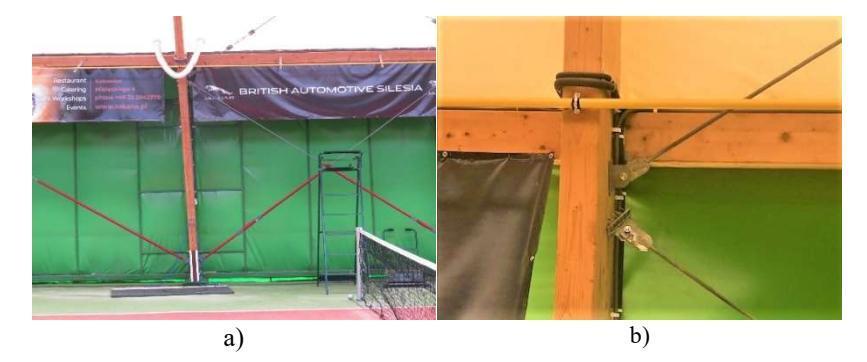
The mining exploitation caused damages and irregularities to the building elements and infrastructure (Fig. 2a, particularly affecting the tilt and deformation of the hall's load-bearing frames. Geodetic measurements [8] revealed significant deflections of the apex from the plane of the frame, with a maximum deflection of 161 mm.

While similar values of vertex displacements were observed based on geodetic measurements, the deviations of the northern segment differed significantly from those of the southern segment. These deflections and changes in the geometry of the braced fields resulted in excessive stress and damage to the bracings (Fig. 2b).

Fig. 2. a) tilt of hall load-bearing frame, b) broken hall bracings

The structure was significantly affected by the pronounced deformation effects of the established concave mining trough, categorized as a 3rd mining category deformation. These effects manifested as horizontal deformations of the mining substrate, resulting in its compaction (ε). The expanded sections of the hall shifted with the terrain, causing displacement of the bases supporting the arched girders. The compressive deformations led to the sliding of foundations. As per the original design [5], the load-bearing transverse structures of the hall lacked full expansion joints along the entire height of the cross-section, contributing to the deformation of the load-bearing frames. The design flaw in this scenario was the absence of an expansion joint in accordance with guidelines [1, 7], from the foundation base to the roof slope. This oversight affected the interaction of the segments, resulting in deflection from the vertical and deformation of the hall's load-bearing frames.

Continued use of the court complex became feasible after implementing recommendations outlined in the study [6]. These recommendations focused on rectifying structural damage, which, if left unaddressed, could render the courts and infrastructure unusable in the event of further deformation.

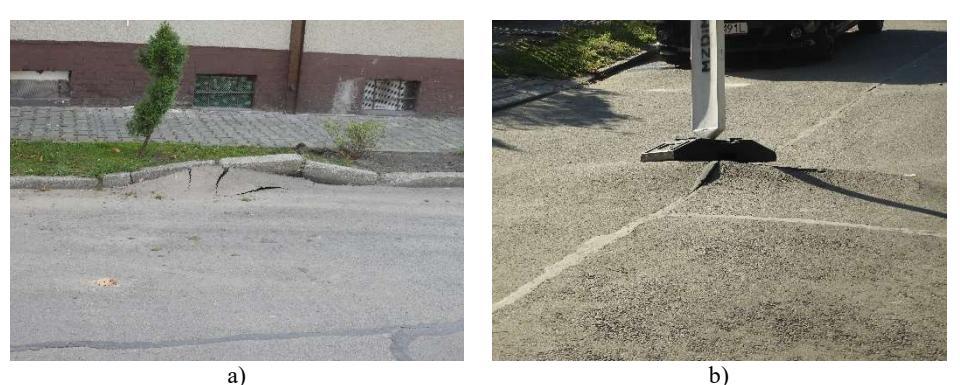
Fig. 1. Terrain thresholds: a) under the pavement and the building on the north-west side of the building, b) in the road surface on the north-west side of the building

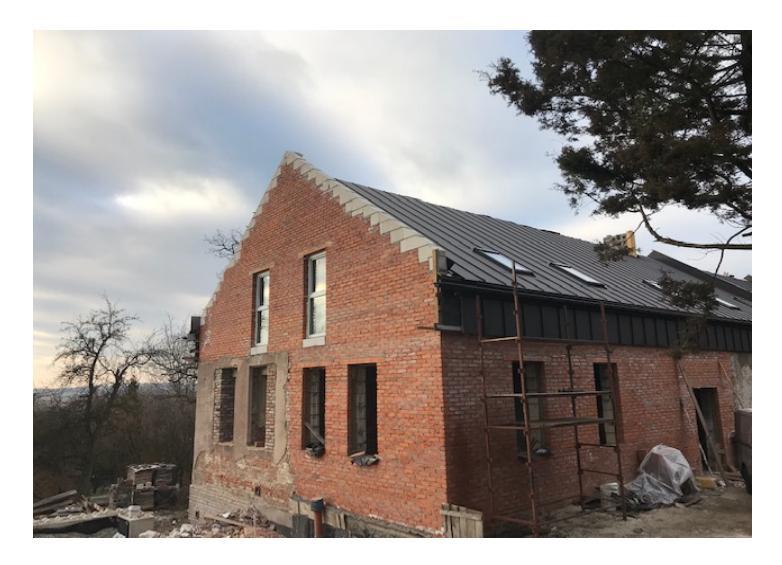
Fig. 2. The view of the building under reconstruction

- Prepare project documentation for the restoration of the collapsed part of the building.
- Conduct construction works related to the restoration of the building (see Fig. 2).

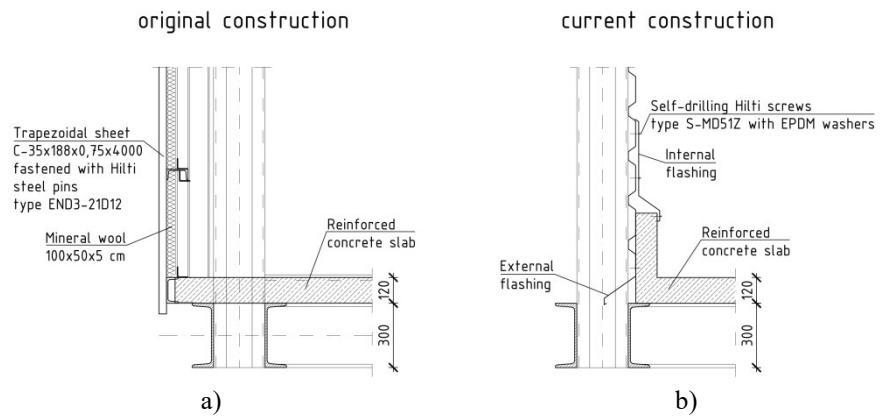
The inclined coal conveyor described in this paper was constructed in 1977 based on design documentation developed in 1975 and was in continuous operation from 1977 to 1999. In 1999, due to its poor technical condition [1, 2], the structure underwent modernization that included updates to the walls, roof, and ceiling of the coal conveyor. Additionally, extensive renovation work was carried out, which involved updating the anti-corrosion protective coatings. The solutions applied during this modernization significantly impacted the subsequent method of loading and using the structure. Notably, the changes made to the ceiling edge were crucial in terms of the later operation of the structure and the deformations observed. The work involved, among other things, the dismantling of a jointless floor slab approximately 40 cm wide along the side trusses on both sides, and the construction of a reinforced concrete plinth 40 cm high, which also incorporated a portion of the adjacent floor slab. The differences in the method of constructing the floor slab according to the original design and after the 1999 modernization are illustrated in Fig. 2.

Fig. 2. Differences in the method of making and supporting the floor slab according to: a) original design solutions, b) condition after the modernization in 1999

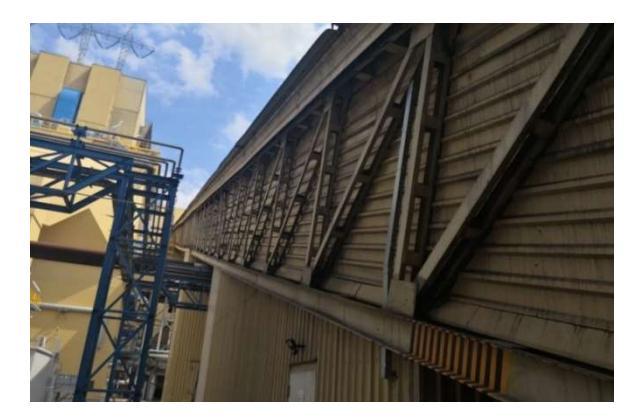
An in-depth analysis of the cyclical archival geodetic measurements of the inclined coal conveyor's geometry confirmed that significant differences in structural deformation were observed between the measurements conducted in the years 1999-2000, coinciding with the period of structural system reconstruction. This period included modifications to the support method and the solution applied to the floor slab edge of the structure [3]. Measurements of the support subsidence did not reveal any irregularities in this regard [4], which, along with the geotechnical tests conducted [5], confirmed the high level of consolidation of the soil subbase below the foundation footing level of the intermediate supports. On-site inspections carried out in the summer of 2020, as well as supplementary geodetic measurements of deformations of the built-up bottom side chords of the longitudinal wall trusses, confirmed the earlier in-situ macroscopic observations, as shown in Fig. 3.

Fig. 3. Deflection of the bottom side chord of the longitudinal wall truss

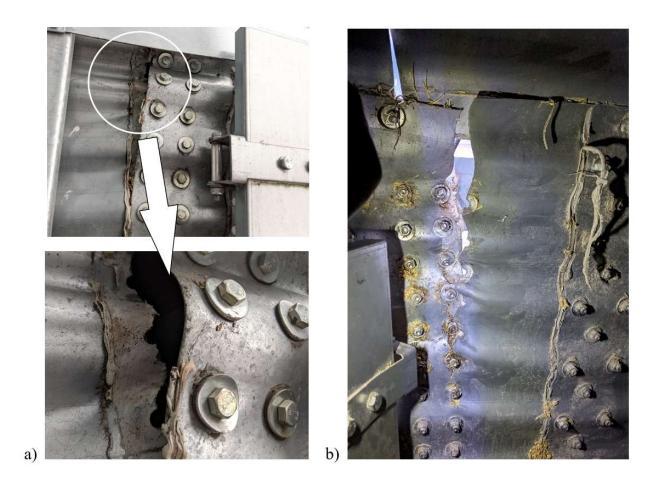
Fig. 2. Details of the wall rupture: a) view from outside b) view from the inside

The failure occurred when the silo was completely filled with wheat, and the discharging operation was initiated. Shortly after the start of the discharging operation, a wall rupture appeared, and a narrow stream of grain began to flow from the location indicated in Fig. 1. The discharging was immediately stopped, and the opening was provisionally blocked. Subsequently, the silo supplier installed strengthening rings (see Fig. 1) to prevent further progression of the rupture. Afterwards, the upper layers of grain were vacuumed out to reduce the silo's capacity to half. The remaining wheat was then discharged using the standard discharging devices installed in the silo. Details of the wall rupture are shown in Fig. 2.

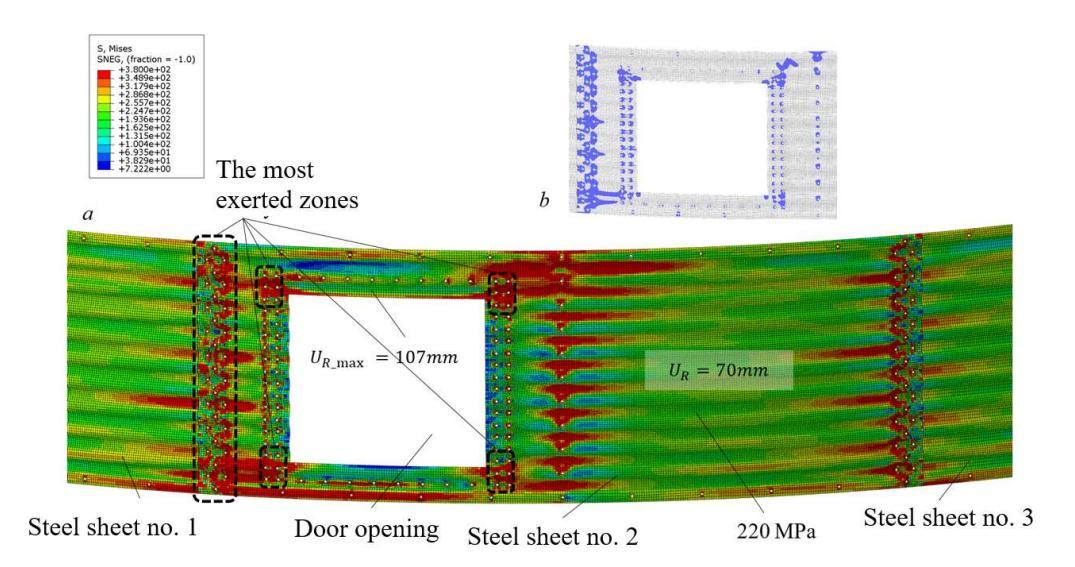
Resistances were checked according to rules given in Eurocodes [4], [5], and [6]. As a result of resistance verifications, it was revealed that some limit states had been surpassed. Specifically, the resistance of the net area of a cross-section along two sections weakened by holes for fasteners (bolts) was too low (measured at 249.09 kN) compared to the calculated axial (peripheral) force at the analyzed location (measured at 259.54 kN). This force also exceeded the bearing resistance of the bolt connection, which was determined to be 225.69 kN. The ratio of exertion was 1.04 (259.54/249.09) and 1.15 (259.54/225.69), respectively, indicating the degree to which the resistance was surpassed.

Fig. 4. Stress and strains distributions within steel sheets: a – equivalent stresses due to Huber-Mises-Hencky hypothesis in [MPa], b – effective plastic strains greater than 0.1%

The most significant results of the numerical simulations are presented in Fig. 4. Equivalent stresses, based on the Huber-Mises-Hencky stress criterion, are shown in Fig. 4a, where spots in dark red indicate zones where the yield state was achieved. Effective plastic strains greater than 0.1% are depicted in Fig. 4b as zones painted blue. "Ur," indicated in Fig. 4a, represents the radial displacement. The plots in Fig. 4 reveal that the most stressed zones occur within the lap connections between steel sheets and in the vicinity of the hatch door housing, precisely where the rupture occurred.

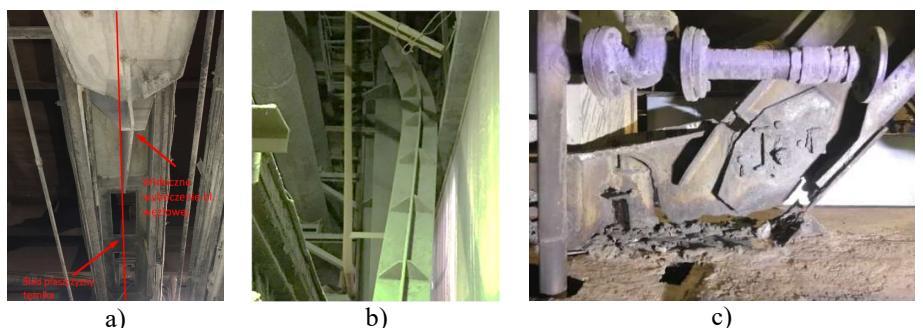
The main cause of structural damage was the uneven settlement of the ground over years of operation. Structures as complex as the skeletal steel frames of the boiler room in a coal power plant are very sensitive to uneven ground settlement. This sensitivity is due to the high degree of static indeterminacy and an additional factor: the suspension of boilers, each with a mass of about 3600 tons, on a grid that rests on top of the supporting columns at a level of about 60 meters

Fig. 3. Damages of the steel structure, a) buckling of gusset plate, b) buckling of a bracing bar, c) ruptured of bracing at the node

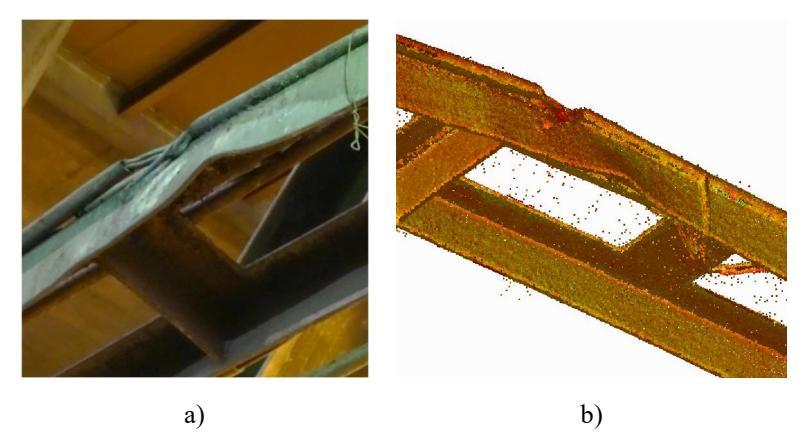
Fig. 4. Comparison of a real-life photo of damaged member with a model from point cloud data

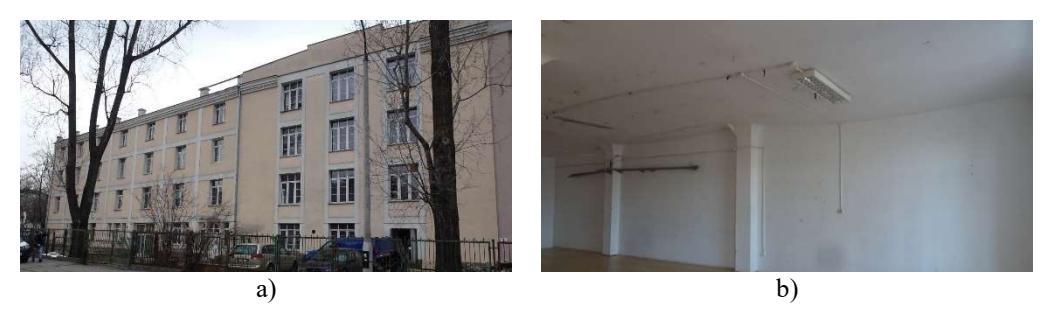
Fig. 1. a) view of the building from the south-east b) visible deflection of the slab above the second floor

Leveling measurements of the deflection of the slabs above the ground floor, first floor, and second floor were conducted. Abnormalities were observed in the ceiling above the second floor, with the deflection of the slab in the front part of the building measured at 102 mm, and the deflection over the central outbuilding at 141 mm. According to [4], deflections exceeding l/250 (where l is the span of the slab) may deteriorate the appearance and functionality of the structure, while deflections greater than l/500 may damage adjoining elements such as partition walls, which are present on the analyzed slabs. Significantly greater deformations directly compromise structural safety. In this context, the measured deflections of the slab did not meet the Serviceability Limit Conditions.

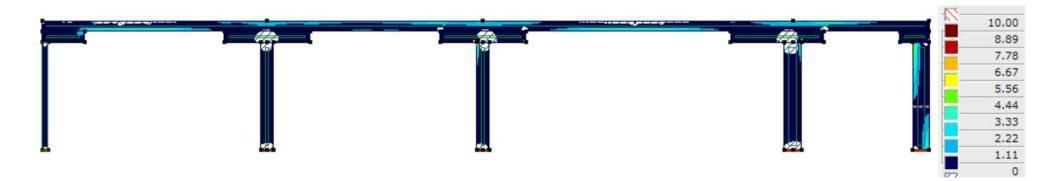
In theory, only compression should occur in the column heads. To explain the cause of the concrete fragment's detachment, static calculations were performed. A spatial shell-bar model of the structure was prepared (Fig. 4), along with a shell model of the roof strip in the axis of the column with the damaged head. The calculations considered the actual constant and variable loads (snow and vehicle), and the live load caused by a truck in the spatial model was analyzed according to the standard [5].

Fig. 4 Tensile stress areas (MPa) in the shell-bar numerical model

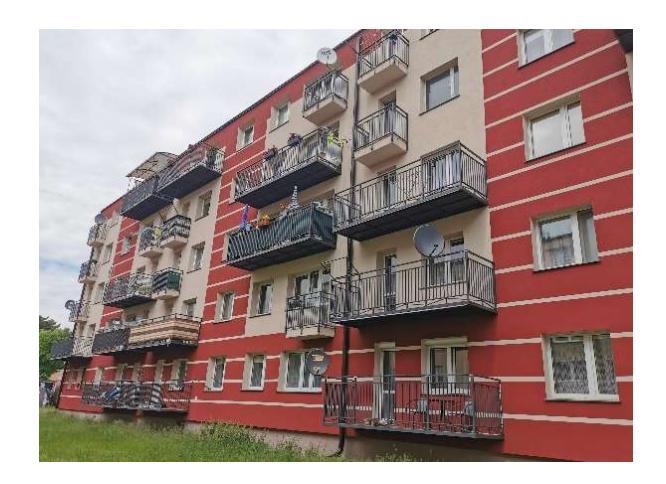
Fig. 2. Poland, Kozienice 2020, fragment of prefabricated building facade. During the insulation of the walls, a major renovation of some of the small balconies was carried out and the remaining ones were replaced to additional balconies of steel construction with PVC panels. Also balconies were added on the first floor

Replacing balconies with larger ones, such as additional ones (Fig. 2), eliminates the problems of technical wear and tear for the next 20-30 years and addresses functional wear and tear.

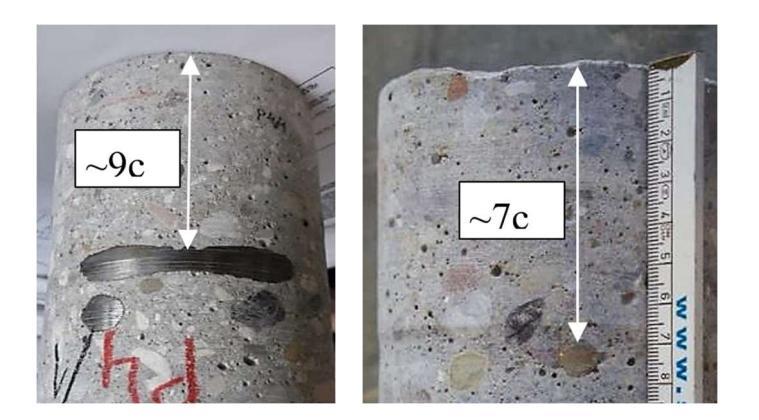
While analyzing the investment process documents, significant changes were found in the detailed design compared to the construction design. The construction design provided for a flat monolithic ceiling with a thickness of 0.35 m. During the construction stage, the ceiling was changed to a composite "filigree" type with a total thickness of 0.28 m. The monolithic concrete overlay was designed using C25/30 concrete, except for small parts hatched in Fig. 1, which were designed with C35/45 concrete. The design specified a nominal cover of the reinforcement equal to 2.5 cm (from the bottom) and 2.0 cm (from the top). Concrete cores taken from the structure showed the actual position of the top reinforcement in the floor slab, as shown in Fig. 2. It was found that the cover of the top reinforcement was exceeded by up to four times.

Fig. 2. View of the cores and cut main bars of the top reinforcement

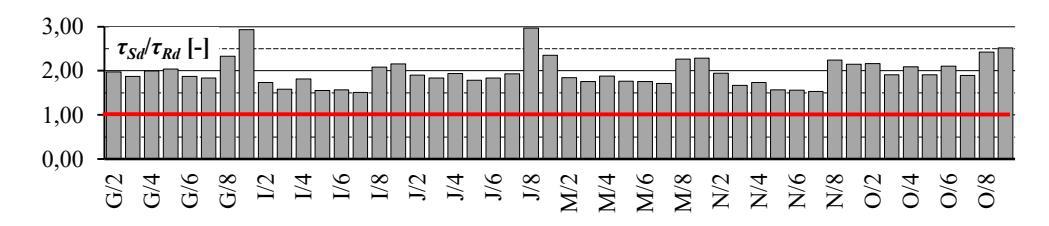
The downward shift of the reinforcement led to a reduction in the effective depth, which significantly influenced the results of calculations related to the punching shear resistance. At the designed loads, the deficit of the punching shear resistance was at the level of about 70% to 170% (see Fig. 3). The analysis carried out under the assumption of the actual loads acting on the slab showed a lower deficit, reaching a maximum of 40%.

Fig. 3. Comparison between shear stress and punching shear resistance for design loads

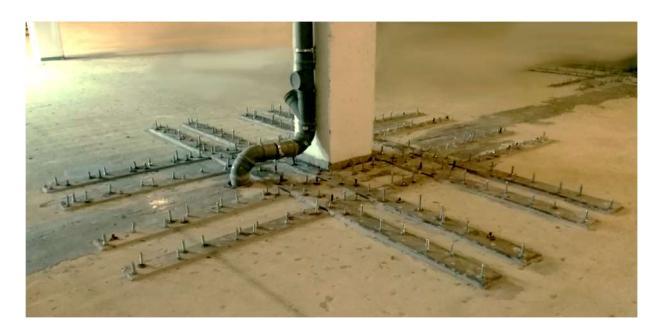
Fig. 4. View of the support zone strengthened with steel flat bars

It was planned to install additional reinforcement as close to the columns as possible, considering the openings in the floor slab. All of the flat bars were perforated with twice as many holes as the number of anchor bolts. The decision to increase the perforation was due to concerns about the possibility of correctly installing the anchor bolts in all intended locations. Due to the high density of reinforcement in the support zone and the potential for assembly deviations, it was necessary to anticipate the possibility of encountering a reinforcing bar. In such cases, drilling had to be stopped and the adjacent hole in the flat bar used for anchoring.

To verify the technical feasibility of the designed solution, a trial strengthening of two support zones was conducted (see Fig. 4). The work, carried out over three days, was divided into stages, including: preparation of the floor surface by removing bleed water, cleaning, and degreasing the glued surfaces; gluing the first layer of flat bars to the concrete; pressing the flat bars with weights during adhesive setting (24 hours); drilling holes in the
