STRUCTURAL FAILURES VADEMECUM 2022

STRUCTURAL FAILURES 2022 VADEMECUM AWARIE BUDOWLANE 2022

MONOGRAPH

prevention diagnostics repairs reconstructions

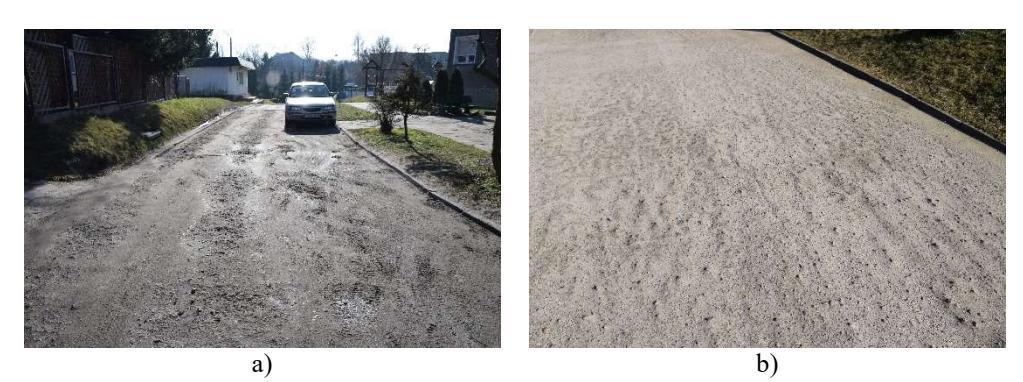
- lack of continuity of support of the surface layer;
- occurrence of localised areas with no drainage;
- deterioration of the pavement texture;
- transverse and diagonal cracks;
- irregular shapes of technological connections of the pavement.
- significant losses of the pavement up to the steel mesh laid on the substructure before the new surface layer was made;
- irregular shapes of technological connections of the pavement.

Fig. 1. Pavement damage: a) pavement degradation, b) damaged to pavement texture, c) exposed steel mesh, d) 6 cm undersized manhole cover

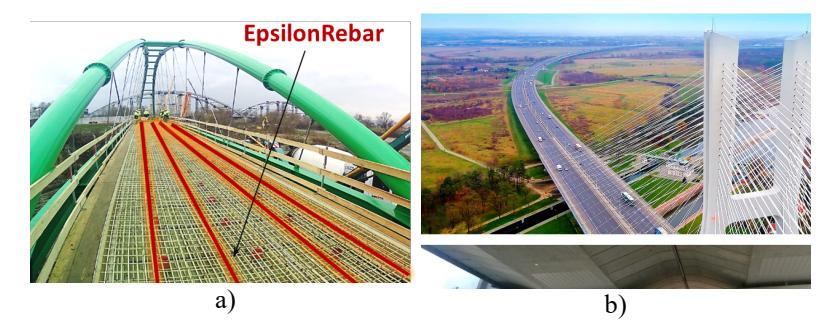
Fig. 1b shows one of the largest concrete bridges in Poland: the Rędziński Bridge in Wrocław. Due to cracks in the horizontal beam of the pylon, EpsilonRebars were installed inside near-to-surface grooves at each corner of the beam. Both short- and long-term measurements allowed for detecting and precisely analyzing crack width changes over time.

Fig. 1. a) Footbridge with composite reinforcement and DFOS sensors [4]; b) one of the largest concrete bridges in Poland with distributed fibre optic strain sensors in the pylons' beam

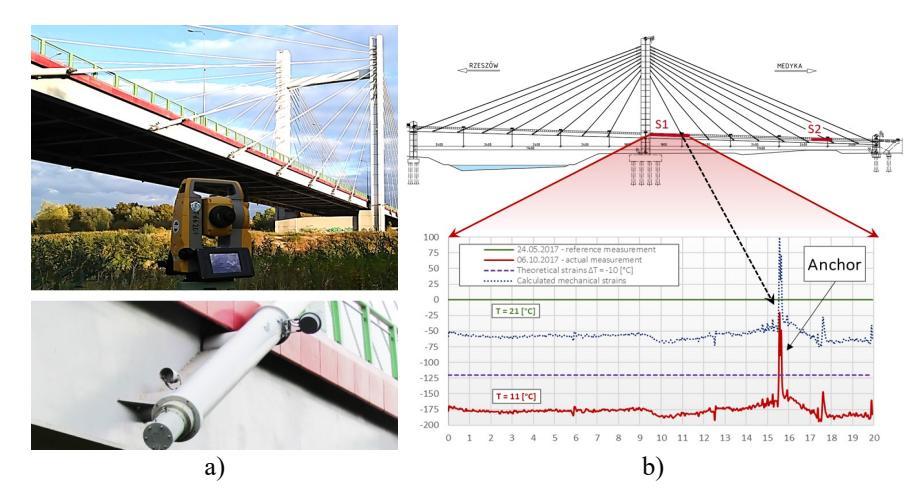
Another project was conducted on an existing steel bridge in Przemyśl, Poland (Fig. 2a). Measurement DFOS fibers were glued to the steel girders using two-component epoxy. The analysis focused particularly on the anchorage zone and local effects influencing the strain profiles within this area.

Example results over a 20 m section (Fig. 2b) indicate that the maximum strain values in the girder, caused by the anchorage, are much greater than those registered in the pure area between the anchorages. This localized strain information is crucial for understanding the structural behavior and integrity of the bridge under various loading conditions.

Fig. 2. "Brama Przemyska" Bridge: a) general view and close-up to the anchorages; b) example results

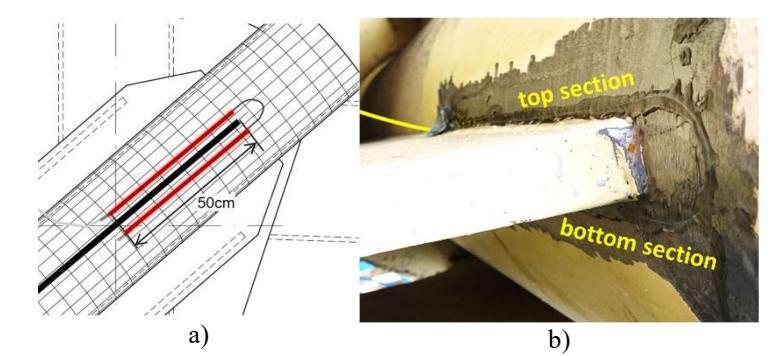
Measurement fibres with a 250 μ m diameter were installed within the anchorages before the cable relieving and annealing. Spatial numerical simulations determined the detailed route. The setup consisted of two sections, each 50 cm long (Fig. 3a). Considering the loop connecting the two sections, the length of the optical fibre at each anchorage was 115 cm. This setup provided 3680 measurement points on 16 anchorages (with a spatial resolution of 5 mm). An important aspect was ensuring the correct strain transfer mechanism through appropriate installation. The sensors were bonded directly to a clean and degreased steel surface (Fig. 3b) after removing the protective

Fig. 3. Measurement sections formed using DFOS optical fibres: a) scheme; b) actual view

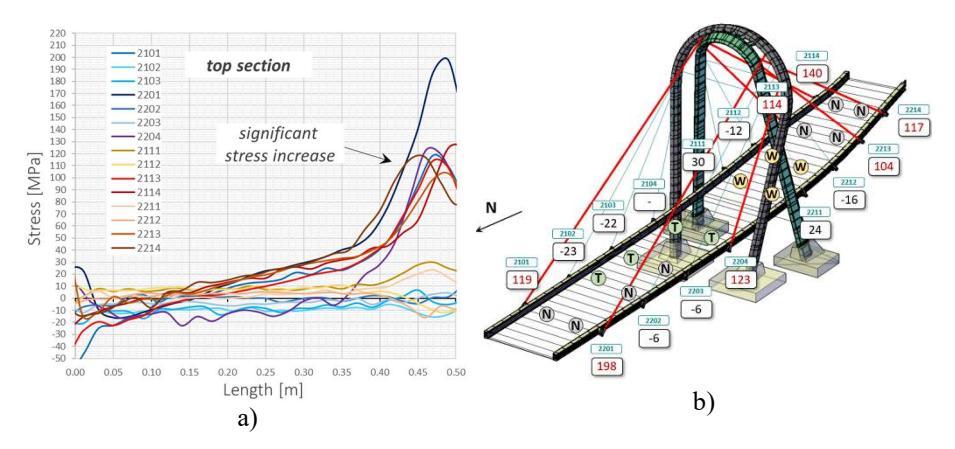
For clarity, the measurement results are presented for the top sections only, for all anchorages. The calculated stress (based on compensated strains and according to Hooke's law) is shown in Fig. 4a. A significant increase in tensile stress was observed on some anchorages (mainly the external ones), while the values were close to zero on the remaining ones. The unique measurement data allowed for identifying the most stressed zones within the anchorage (local analysis) and the most stressed anchorages within the bridge (global analysis). To facilitate graphical interpretation, the maximum stress values recorded in each anchorage are presented in a spatial visualization (Fig. 4a). The red color indicates the cables at which significant deformations were observed at the anchorages.

Rys. 4. Example stress results: a) distributions over the length of the top section; b) spatial visualisation with maximum stress values [MPa]

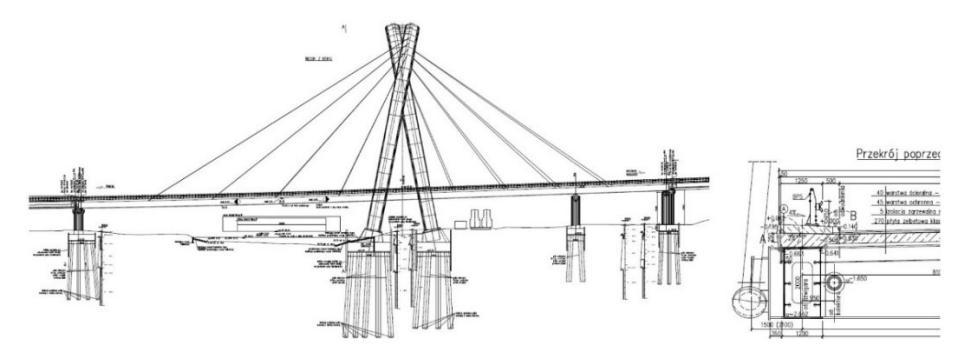
Fig. 2. University Bridge - suspended part, side view and cross-section [1]

The designer of the route is Transprojekt Gdański [1], and the contractor is a consortium of companies Mosty Łódź SA and Gotowski Sp. z o.o. The construction process was supported by an advisory consulting team [2]. Before opening, the bridge underwent a load test process [3,4]. The route was opened on November 30, 2013. The static scheme of the bridge is a continuous beam suspended to a pylon with spans of 110 + 90 m (Fig. 2).

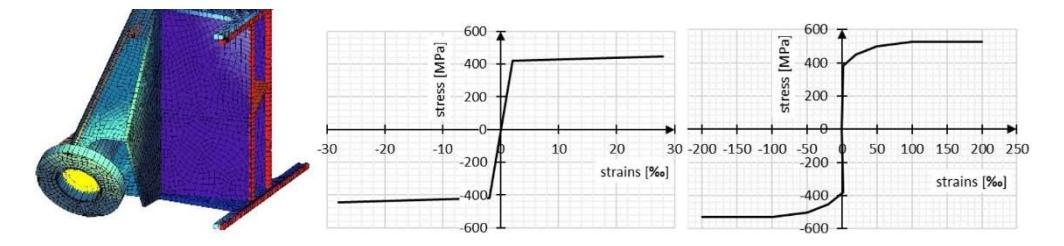
As part of the theoretical analysis [5, 6], a global FEM model of the bridge structure was developed. The next step involved creating detailed models of the anchor details. These models were constructed entirely as shell models, using the QUAD 4 element in the SOFiSTiK FEM environment (Fig. 4).

Fig. 4. FEM model of the anchorage with a typical boundary conditions system, material law no. 1 and no. 2 applied in the analyses

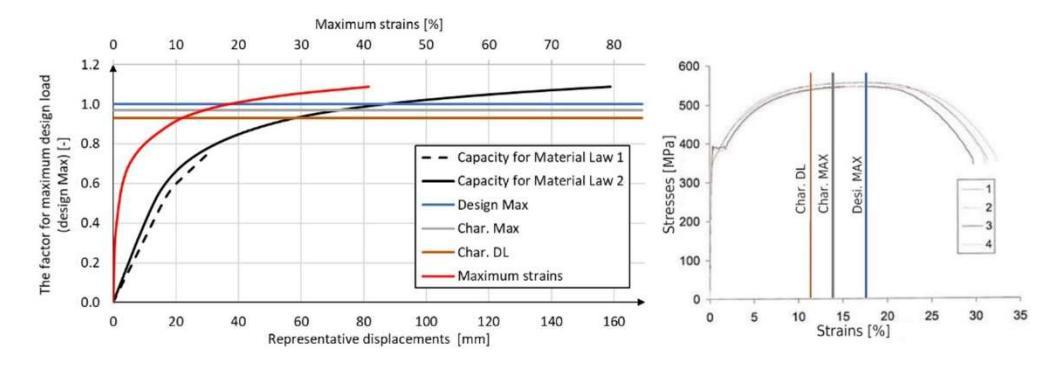
Fig. 5. Result of the nonlinear computation (left side) and material low no. 3 (right side)

Fig. 5 presents a summary of the nonlinear analyses of the element capacity. Material law no. 1 was used for the engineering analysis, limited by the maximum strain value of 5%. Law no. 2 was defined based on experimental research [7] (law no. 3) and used to analyze the full range of strain. The diagram (Fig. 5–law no. 3) shows the result of the uniaxial tension test. The vertical lines indicate strain values at the characteristic load levels of the

structure. The analysis shows that under the characteristic dead load (Char. DL), the material reaches full plasticity, and the strain in steel exceeds approximately 10%. Similar results were obtained in [8, 9]. However, the authors of these works presented a different opinion on the safety of the structure, considering the closure of the bridge as an unjustified action.

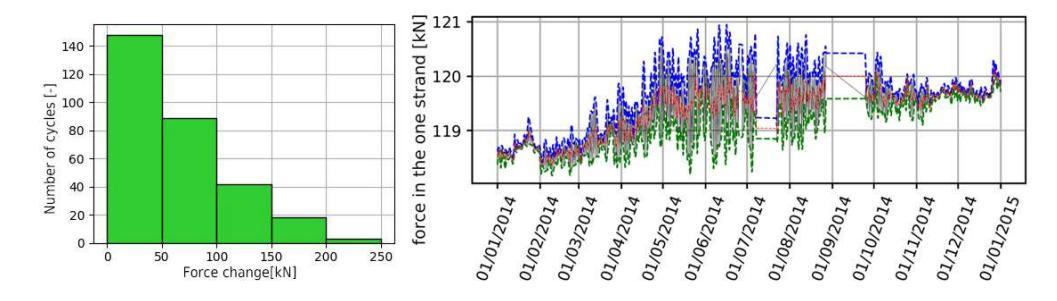
Fig. 6. Annual histogram of the daily force variation in the suspension cable and variation of the force in the only one strand of the critical suspension cable

Fig. 6 shows the distribution of daily force changes in the cable based on the SHM (Structural Health Monitoring) system installed on the bridge. This phenomenon contributes to the problem of low-cycle fatigue strength, with a constant strain of 10% and the one-year load variation presented in Fig. 6.
