DAISUKE YAMAOKA, *yamaoka_dai_ssd@yahoo.co.jp*

KAZUYA BESSHO, *bessho_ssd@yahoo.co.jp*

FATIGUE TEST OF AN URBAN EXPRESSWAY STEEL GIRDER BRIDGE CONSTRUCTED IN 1964

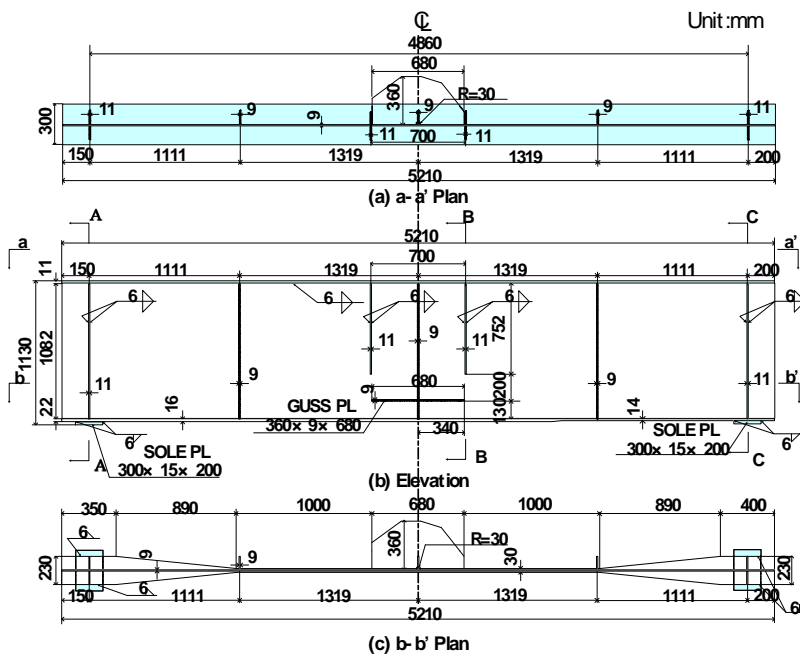
Fig. 6. Configurations and Dimensions of G1 Girder Specimen

Fig. 6 shows the configurations and dimensions of G1 girder specimen. Due to the capacity of the testing machine, the depth of girder was reduced by cutting off the upper part of the girder and welded a new top flange. Photo 5 shows the gusset plate in G1 girder specimen. The gusset plate has fillets at its both ends.

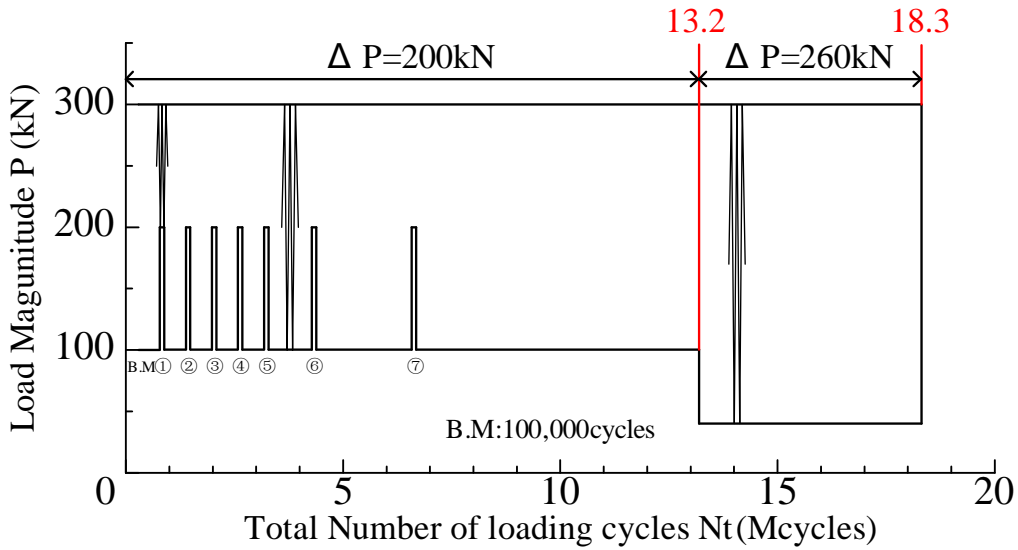
Fig. 7. Fatigue Loading History

Fatigue test was conducted in 4-point bending condition with a loading beam. Loading rate was 3 Hz. Fig. 7 shows fatigue loading history. After $\Delta P = 200$ kN fatigue loading of

12.5 Mcycles, MT signs at the gusset plate end was propagated so little that. The load range (ΔP) was increased to 260 kN.
