Structural safety: lessons from the partial collapse of a multi-story car park

JOOST WALRAVEN

Abstract: At 27th of May 2017 a large part of a new multistory car park at the Airport of Eindhoven in The Netherlands collapsed. This collapse occurred a few weeks before the official opening. It turned out that the floors of the building were made according to the so-called Bubble Deck system. This consists of precast concrete planks on top of which reinforcement is provided, in combination with polypropylene spheres. This floor system leads to a light and nevertheless stiff floor. In the past the slabs were design to predominantly carry the loads in one direction. In the last decade the system was changed in such a way that it could carry the load in two principal directions. However, the joints were detailed incorrectly, which resulted in the collapse. It was remarkable that in the 15 years that this detail was used, nobody was aware of the risk of its application. That implies that many other existing buildings might be unsafe as well. In this paper the consequences and solutions are treated.

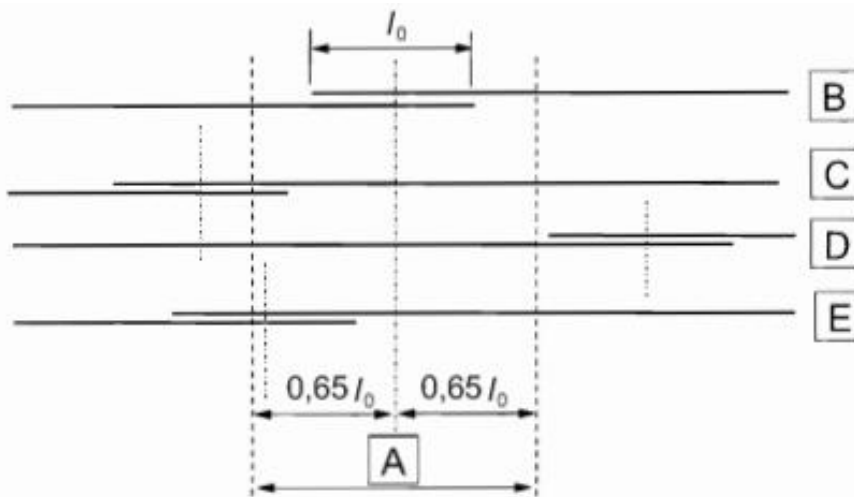
Considering the critical joint as a lapped splice, in section 8.7.2 (2) of EN 1992-1-1 it is recommended that laps between bars should normally be staggered and especially not concentrated in areas with large bending moments (fig. 6). In the case considered the critical joint, leading to collapse, was located near to the maximum bending moment at mid-span, whereas the coupling bars were not staggered. This is already a situation which can be described as “risky”.

Fig. 6. Avoiding too many lapped slices in one cross-section (according to EN 1992-1-1, Section 8.7.3).
